Access Compliance Report

Public Rights-of-Way

(Curb Ramps)

Intersection ID: 9497	Main Street: BENARD_AV	Cross Street: E_36TH_ST	Location: SW
ADA ID: 2171D9AADFF4	Ramp Type: Perp	Initial Pass/Fail: Fail	Overall Compliance: No
Severity Score: 22.5			
Codes/Mitigation Info/Possible Solution		Field Measurements/Component Compliance

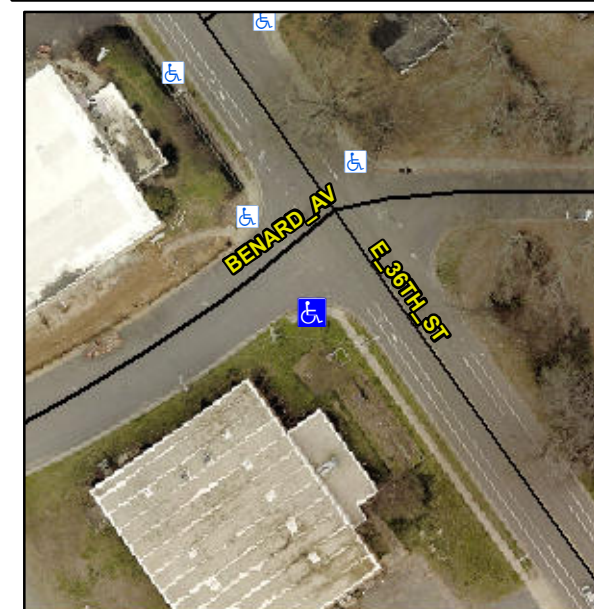
Not Found, R304.5.1, R304.2.2, R304.5.3

Compliance	Description	Data	Compliance	Description	Data
N/A	Ramp Length (in)	58.5	No	Ramp Slope (%)	8.4
No	Ramp Width (in)	42.0	No	Ramp XSlope (%)	3.3
N/A	Flare Type LT	N/A	N/A	Flare Type RT	N/A
N/A	Flare Slope LT (%)	N/A	N/A	Flare Slope RT (%)	N/A
N/A	Flare Traversable LT?	N/A	N/A	Flare Traversable RT?	N/A
N/A	Landing Length (in)	N/A	N/A	DWS Provided?	N/A
N/A	Landing Width (in)	N/A	N/A	DWS Contrast?	N/A
N/A	Landing Slope (%)	N/A	N/A	DWS Length (in)	N/A
N/A	Landing X Slope (%)	N/A	N/A	DWS Full Width?	N/A
N/A	Landing Curb? (Y/N)	N/A	N/A	DWS Offset (in)	N/A
N/A	Shared Landing?	N/A			
N/A	Gutter Ponding?	N/A	N/A	Gutter Slope (%)	N/A
N/A	Gutter Lip Ht (in)	0.5	N/A	Gutter X Slope (%)	N/A
N/A	Painted X Walk1?	No	N/A	Painted X Walk2?	N/A
	X Walk 1 Direction	To NW		X Walk 2 Direction	N/A
N/A	X Walk 1 Width (in)	N/A	N/A	X Walk 2 Width (in)	N/A
	X Walk 1 Slope (%)	1.9		X Walk 2 Slope (%)	N/A
	X Walk 1 X Slope (%)	0.1		X Walk 2 X Slope (%)	N/A

N/A	Ramp inside XWalk1?	N/A	N/A	Ramp inside XWalk2?	N/A
	Road Slope (%)	N/A	N/A	Clear Space?	N/A
	Road X Slope (%)	N/A	N/A	Clear Space to XWalk (in)	N/A
N/A	Any Obstructions?	N/A	N/A	Storm Grate/Utility Hazard?	N/A
	Obstruction Type			Storm Grate/Utility Type	
		N/A			N/A
			Yes	Surface Condition? (G/P)	Good

Possible Solutions:

Remove & Replace Entire Ramp.
