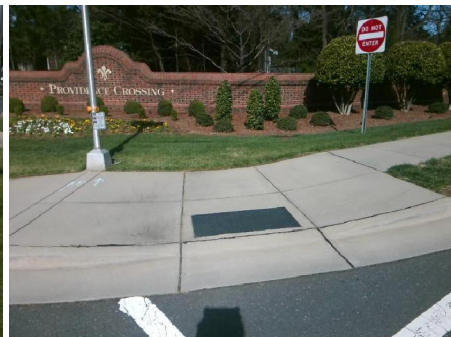
Possible Solutions:		Remove & Replace Entire Ramp.	
	Surveyor Notes:		LT RP < 5%	
	PROW/ADA:		R304.5.3, R304.3.2	
	Total Cost:		\$ 1600.00	
Street 1 Name	PROVIDENCE RD		Street 2 Name	N/A
Stop Condition-Street 1	Signal		Stop Condition-Street 2	N/A

Compliance	Description	Data	Compliance	Description	Data
N/A	Ramp Length LT (in)	60.5	N/A	Ramp Length RT (in)	61.0
Yes	Ramp Width LT (in)	59.0	Yes	Ramp Width RT (in)	59.0
Yes	Ramp Slope LT (%)	1.2	No	Ramp Slope RT (%)	12.6
No	Ramp XSlope LT (%)	2.7	Yes	Ramp XSlope RT (%)	2.0
N/A	Landing Length (in)	N/A	N/A	DWS Provided?	N/A
N/A	Landing Width (in)	N/A	N/A	DWS Contrast?	N/A
N/A	Landing Slope (%)	N/A	N/A	DWS Length (in)	N/A
N/A	Landing X Slope (%)	N/A	N/A	DWS Full Width?	N/A
N/A	Landing Curb? (Y/N)	N/A	N/A	DWS Offset (in)	N/A
N/A	Shared Landing?	N/A	N/A	Gutter Slope (%)	N/A
N/A	Gutter Ponding?	N/A	N/A	Gutter X Slope (%)	N/A
N/A	Gutter Lip Ht (in)	N/A	N/A	Painted X Walk2?	N/A
N/A	Painted X Walk1?	Yes	N/A	X Walk 2 Direction	N/A
	X Walk 1 Direction	To E	N/A	X Walk 2 Width (in)	N/A
N/A	X Walk 1 Width (in)	105.0		X Walk 2 Slope (%)	N/A
	X Walk 1 Slope (%)	1.6		X Walk 2 X Slope (%)	N/A
	X Walk 1 X Slope (%)	2.6	N/A	Ramp inside XWalk2?	N/A

N/A	Ramp inside XWalk1?	Yes	N/A	Clear Space?	N/A
	Road Slope (%)	N/A	N/A	Clear Space to XWalk (in)	N/A
	Road X Slope (%)	N/A	N/A	Storm Grate/Utility Hazard?	N/A
N/A	Any Obstructions?	N/A		Storm Grate/Utility Type	
	Obstruction Type				
		N/A			N/A
			Yes	Surface Condition? (G/P)	Good
			N/A	Curb Slope (%)	18.2
