Access Compliance Report

Public Rights-of-Way (Curb Ramps)

Intersection ID: 50485	Main Street: JONES_CROSSING_RD	Cross Street: HAWFIELD_WAY_DR	Location: NW
ADA ID: 217BDF593024	Ramp Type: PerpDiag	Initial Pass/Fail: Fail	Overall Compliance: No
Severity Score: 46.25			
Codes/Mitigation Info/Possible Solution		Field Measurements/Component Compliance

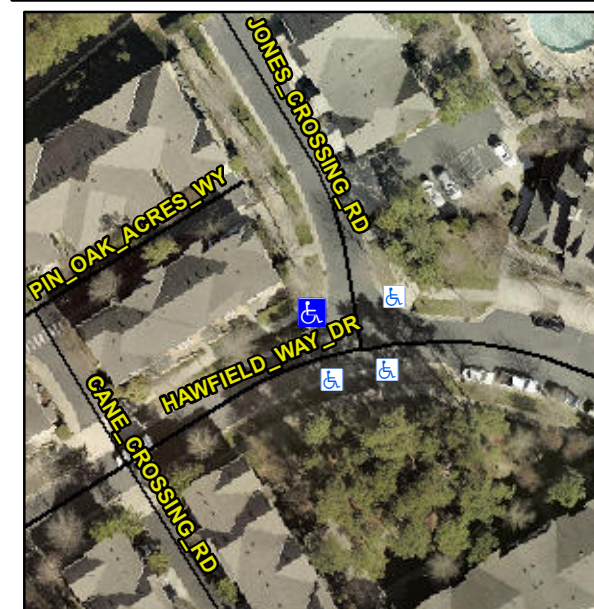
Not Found, R304.5.1, R304.2.2, R304.5.3

Compliance	Description	Data	Compliance	Description	Data
N/A	Ramp Length (in)	165.0	No	Ramp Slope (%)	8.6
No	Ramp Width (in)	47.0	No	Ramp XSlope (%)	10.0
N/A	Flare Type LT	N/A	N/A	Flare Type RT	N/A
N/A	Flare Slope LT (%)	N/A	N/A	Flare Slope RT (%)	N/A
N/A	Flare Traversable LT?	N/A	N/A	Flare Traversable RT?	N/A
N/A	Landing Length (in)	N/A	N/A	DWS Provided?	N/A
N/A	Landing Width (in)	N/A	N/A	DWS Contrast?	N/A
N/A	Landing Slope (%)	N/A	N/A	DWS Length (in)	N/A
N/A	Landing X Slope (%)	N/A	N/A	DWS Full Width?	N/A
N/A	Landing Curb? (Y/N)	N/A	N/A	DWS Offset (in)	N/A
N/A	Shared Landing?	N/A			
N/A	Gutter Ponding?	N/A	N/A	Gutter Slope (%)	N/A
N/A	Gutter Lip Ht (in)	N/A	N/A	Gutter X Slope (%)	N/A
N/A	Painted X Walk1?	No	N/A	Painted X Walk2?	No
	X Walk 1 Direction	To S		X Walk 2 Direction	To E
N/A	X Walk 1 Width (in)	N/A	N/A	X Walk 2 Width (in)	N/A
	X Walk 1 Slope (%)	1.7		X Walk 2 Slope (%)	3.6
	X Walk 1 X Slope (%)	4.2		X Walk 2 X Slope (%)	1.3

N/A	Ramp inside XWalk1?	N/A	N/A	Ramp inside XWalk2?	N/A
	Road Slope (%)	4.3	N/A	Clear Space?	N/A
	Road X Slope (%)	1.7	N/A	Clear Space to XWalk (in)	N/A
N/A	Any Obstructions?	N/A	N/A	Storm Grate/Utility Hazard?	N/A
	Obstruction Type			Storm Grate/Utility Type	
		N/A			N/A
		Yes		Surface Condition? (G/P)	Good

Possible Solutions:

Remove & Replace Curb Ramp With Two New Directional Ramps or Equivalent.
