Access Compliance Report

Public Rights-of-Way

(Curb Ramps)

Intersection ID: 3770	Main Street: LEXINGTON_APPROACH_DR	Cross Street: TAVERNAY_PY	Location:	N
ADA ID: 21839425C387	Ramp Type: Perp	Initial Pass/Fail: Fail	Overall Compliance: No	Severity Score: 25
Codes/Mitigation Info/Possible Solution		Field Measurements/Component Compliance

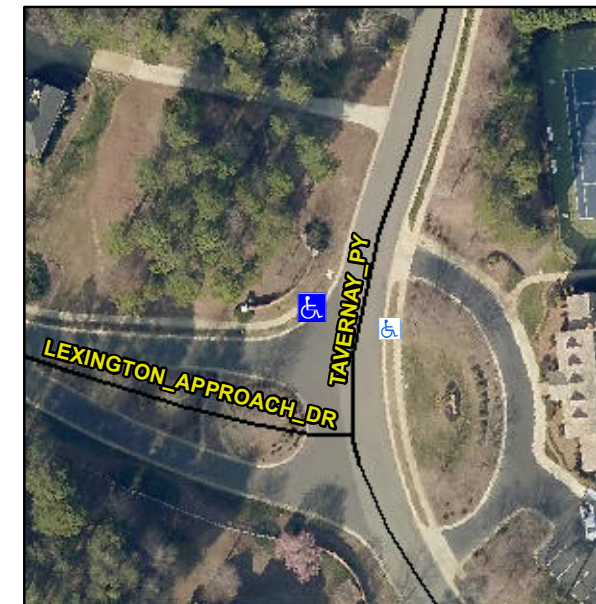
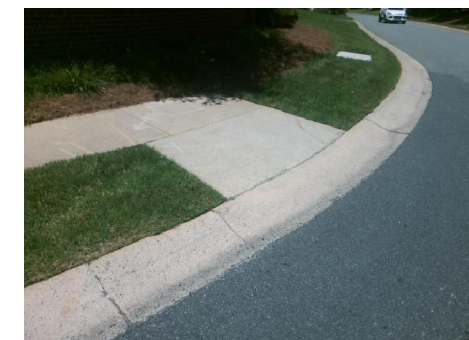
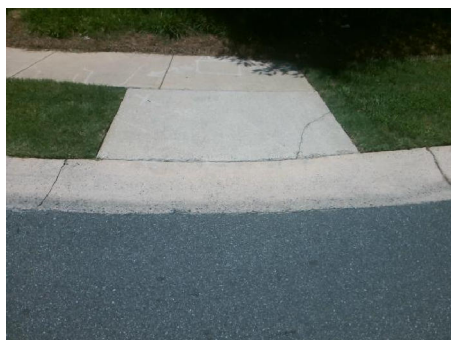
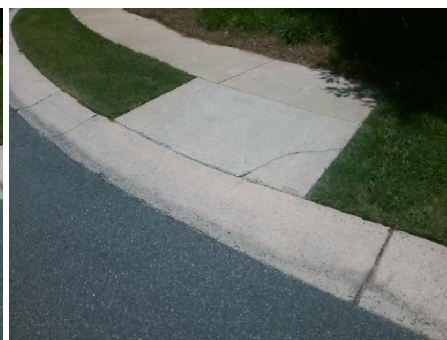
Not Found, R304.2.2

Compliance	Description	Data	Compliance	Description	Data
N/A	Ramp Length (in)	49.0	No	Ramp Slope (%)	13.8
Yes	Ramp Width (in)	48.0	Yes	Ramp XSlope (%)	0.5
N/A	Flare Type LT	N/A	N/A	Flare Type RT	N/A
N/A	Flare Slope LT (%)	N/A	N/A	Flare Slope RT (%)	N/A
N/A	Flare Traversable LT?	N/A	N/A	Flare Traversable RT?	N/A
N/A	Landing Length (in)	N/A	N/A	DWS Provided?	N/A
N/A	Landing Width (in)	N/A	N/A	DWS Contrast?	N/A
N/A	Landing Slope (%)	N/A	N/A	DWS Length (in)	N/A
N/A	Landing X Slope (%)	N/A	N/A	DWS Full Width?	N/A
N/A	Landing Curb? (Y/N)	N/A	N/A	DWS Offset (in)	N/A
N/A	Shared Landing?	N/A			
N/A	Gutter Ponding?	N/A	N/A	Gutter Slope (%)	N/A
N/A	Gutter Lip Ht (in)	N/A	N/A	Gutter X Slope (%)	N/A
N/A	Painted X Walk1?	No	N/A	Painted X Walk2?	N/A
	X Walk 1 Direction	To SE		X Walk 2 Direction	N/A
N/A	X Walk 1 Width (in)	N/A	N/A	X Walk 2 Width (in)	N/A
	X Walk 1 Slope (%)	0.8		X Walk 2 Slope (%)	N/A
	X Walk 1 X Slope (%)	8.2		X Walk 2 X Slope (%)	N/A

N/A	Ramp inside XWalk1?	N/A	N/A	Ramp inside XWalk2?	N/A
	Road Slope (%)	N/A	N/A	Clear Space?	N/A
	Road X Slope (%)	N/A	N/A	Clear Space to XWalk (in)	N/A
N/A	Any Obstructions?	N/A	N/A	Storm Grate/Utility Hazard?	N/A
	Obstruction Type			Storm Grate/Utility Type	
		N/A			N/A
			Yes	Surface Condition? (G/P)	Good

Remove & Replace Entire Ramp.

Total Cost: \$ 1850.00
