Access Compliance Report

Public Rights-of-Way

(Curb Ramps)

Intersection ID: 10019428	Main Street: ALDERGROVE_RD	Cross Street: N/A	Location:	E
ADA ID: 218553AC1D1D	Ramp Type: Perp	Initial Pass/Fail: Fail	Overall Compliance: No	Severity Score: 8.75
Codes/Mitigation Info/Possible Solution		Field Measurements/Component Compliance

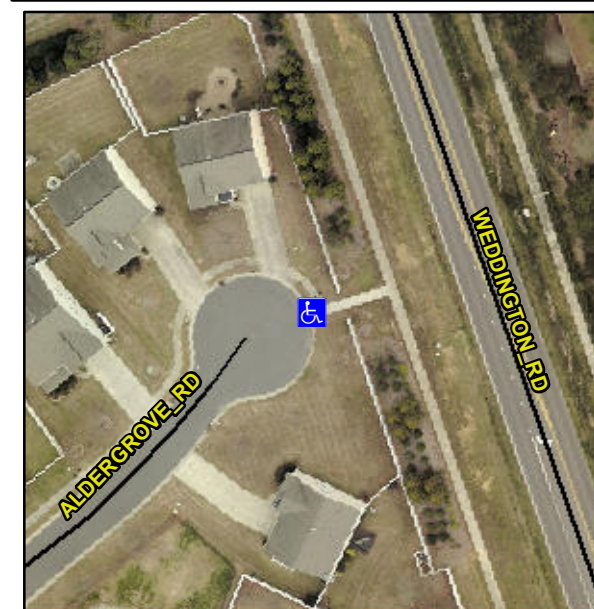
Not Found, R304.5.1

Compliance	Description	Data	Compliance	Description	Data
N/A	Ramp Length (in)	58.0	Yes	Ramp Slope (%)	8.0
No	Ramp Width (in)	47.0	Yes	Ramp XSlope (%)	0.7
N/A	Flare Type LT	N/A	N/A	Flare Type RT	N/A
N/A	Flare Slope LT (%)	N/A	N/A	Flare Slope RT (%)	N/A
N/A	Flare Traversable LT?	N/A	N/A	Flare Traversable RT?	N/A
N/A	Landing Length (in)	N/A	N/A	DWS Provided?	N/A
N/A	Landing Width (in)	N/A	N/A	DWS Contrast?	N/A
N/A	Landing Slope (%)	N/A	N/A	DWS Length (in)	N/A
N/A	Landing X Slope (%)	N/A	N/A	DWS Full Width?	N/A
N/A	Landing Curb? (Y/N)	N/A	N/A	DWS Offset (in)	N/A
N/A	Shared Landing?	N/A			
N/A	Gutter Ponding?	N/A	N/A	Gutter Slope (%)	N/A
N/A	Gutter Lip Ht (in)	N/A	N/A	Gutter X Slope (%)	N/A
N/A	Painted X Walk1?	No	N/A	Painted X Walk2?	N/A
	X Walk 1 Direction	To W		X Walk 2 Direction	N/A
N/A	X Walk 1 Width (in)	N/A	N/A	X Walk 2 Width (in)	N/A
	X Walk 1 Slope (%)	1.3		X Walk 2 Slope (%)	N/A
	X Walk 1 X Slope (%)	1.2		X Walk 2 X Slope (%)	N/A

Remove & Replace Entire Ramp.
