Access Compliance Report Public Rights-of-Way (Curb Ramps)

Intersection ID: 50239 Main Street: EVERGREEN_TERRACE_DR Cross Street: LONGSTONE_LN Location: SW

ADA ID: 2194BE1865E3 Ramp Type: Perp Initial Pass/Fail: Fail Overall Compliance: No Severity Score: 12.5

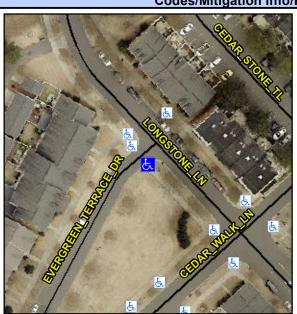
Field Measurements/Component Compliance						
Compliance Description		Data	Comp	liance	Description	Data
N/A	Ramp Length (in)	59.0	No	Ramp	Slope (%)	9.3
Yes	Ramp Width (in)	48.0	Yes	Ramp	XSlope (%)	0.4
N/A	Flare Type LT	N/A	N/A	Flare	Type RT	N/A
N/A	Flare Slope LT (%)	N/A	N/A	Flare	Slope RT (%)	N/A
N/A	Flare Traversable LT?	N/A	N/A	Flare	Traversable RT?	N/A
N/A	Landing Length (in)	N/A	N/A	DWS	Provided?	N/A
N/A	Landing Width (in)	N/A	N/A	DWS	Contrast?	N/A
N/A	Landing Slope (%)	N/A	N/A	DWS	Length (in)	N/A
N/A	Landing X Slope (%)	N/A	N/A	DWS	Full Width?	N/A
N/A	Landing Curb? (Y/N)	N/A	N/A	DWS	Offset (in)	N/A
N/A	Shared Landing?	N/A				
N/A	Gutter Ponding?	N/A	N/A	Gutte	r Slope (%)	N/A
N/A	Gutter Lip Ht (in)	N/A	N/A	Gutte	r X Slope (%)	N/A
N/A	Painted X Walk1?	No	N/A	Painte	ed X Walk2?	N/A
	X Walk 1 Direction	To NW		X Wal	lk 2 Direction	N/A
N/A	X Walk 1 Width (in)	N/A	N/A	X Wal	lk 2 Width (in)	N/A
	X Walk 1 Slope (%)	0.0		X Wal	lk 2 Slope (%)	N/A

X Walk 1 X Slope (%)	1.4		X Wal	lk 2 X Slope (%)	N/A
N/A	Ramp inside XWalk1?	N/A	N/A	Ramp	inside XWalk2?	N/A
	Road Slope (%)	N/A	N/A	Clear	Space?	N/A
	Road X Slope (%)	N/A	N/A	Clear	Space to XWalk (in)	N/A
N/A	Any Obstructions?	N/A	N/A	Storm	Grate/Utility Hazard?	N/A
	Obstruction Type			Storm	Grate/Utility Type	
		N/A				N/A
			Yes	Surfac	ce Condition? (G/P)	Good

Remove & Replace Entire Ramp.
