# Access Compliance Report

## Public Rights-of-Way

### (Curb Ramps)

Intersection ID: 19461	Main Street: CHARTER_PL	Cross Street: LIDO_AV	Location: W
ADA ID: 219820779FCF	Ramp Type: PerpDiag	Initial Pass/Fail: Fail	Overall Compliance: No
Codes/Mitigation Info/Possible Solution		Field Measurements/Component Compliance	
Severity Score: 12.5

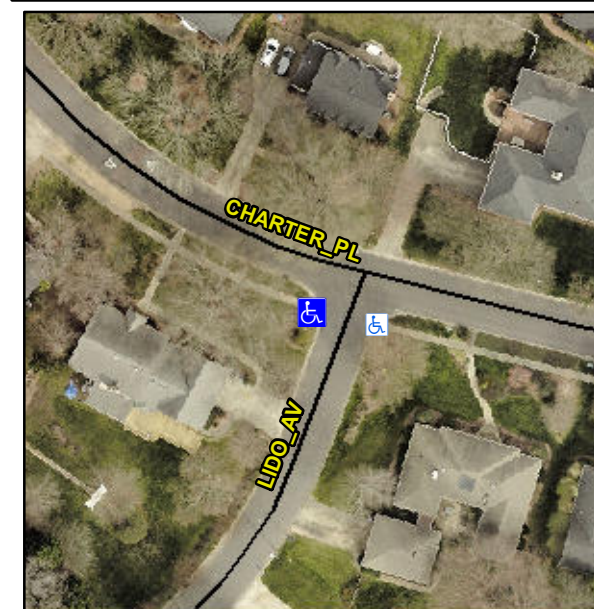
**Not Found, R304.2.2**

Compliance	Description	Data	Compliance	Description	Data
N/A	Ramp Length (in)	63.0	No	Ramp Slope (%)	8.6
Yes	Ramp Width (in)	48.0	Yes	Ramp XSlope (%)	1.8
N/A	Flare Type LT	N/A	N/A	Flare Type RT	N/A
N/A	Flare Slope LT (%)	N/A	N/A	Flare Slope RT (%)	N/A
N/A	Flare Traversable LT?	N/A	N/A	Flare Traversable RT?	N/A
N/A	Landing Length (in)	N/A	N/A	DWS Provided?	N/A
N/A	Landing Width (in)	N/A	N/A	DWS Contrast?	N/A
N/A	Landing Slope (%)	N/A	N/A	DWS Length (in)	N/A
N/A	Landing X Slope (%)	N/A	N/A	DWS Full Width?	N/A
N/A	Landing Curb? (Y/N)	N/A	N/A	DWS Offset (in)	N/A
N/A	Shared Landing?	N/A			
N/A	Gutter Ponding?	N/A	N/A	Gutter Slope (%)	N/A
N/A	Gutter Lip Ht (in)	N/A	N/A	Gutter X Slope (%)	N/A
N/A	Painted X Walk1?	No	N/A	Painted X Walk2?	No
	X Walk 1 Direction	To SE		X Walk 2 Direction	To NE
N/A	X Walk 1 Width (in)	N/A	N/A	X Walk 2 Width (in)	N/A
	X Walk 1 Slope (%)	6.6		X Walk 2 Slope (%)	5.6
	X Walk 1 X Slope (%)	2.9		X Walk 2 X Slope (%)	6.0

N/A	Ramp inside XWalk1?	N/A	N/A	Ramp inside XWalk2?	N/A
	Road Slope (%)	0.5	N/A	Clear Space?	N/A
	Road X Slope (%)	8.1	N/A	Clear Space to XWalk (in)	N/A
N/A	Any Obstructions?	N/A	N/A	Storm Grate/Utility Hazard?	N/A
	Obstruction Type			Storm Grate/Utility Type	
		N/A			N/A
		Yes		Surface Condition? (G/P)	Good

Possible Solutions:

**Remove & Replace Curb Ramp With Two New Directional Ramps or Equivalent.**

Total Cost: \$ 3200.00
