Access Compliance Report

Public Rights-of-Way

(Curb Ramps)

Intersection ID: 13032	Main Street: PROSPECT_ST	Cross Street: CENTRAL_AV	Location: SE
ADA ID: 219B39D776F3	Ramp Type: Directional1	Initial Pass/Fail: Fail	Overall Compliance: No
		Severity Score: 12.5

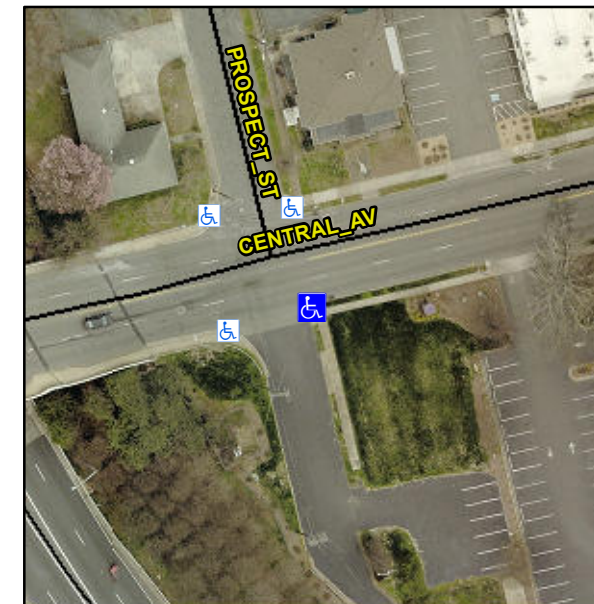
Compliance	Description	Data	Compliance	Description	Data
N/A	Ramp Length (in)	108.0	N/A	Grade Break?	N/A
Yes	Ramp Width (in)	48.5	N/A	Grade Break Slope (%)	0.0
No	Ramp Slope (%)	8.5	N/A	Grade Break XSlope (%)	0.0
Yes	Ramp XSlope (%)	0.9			
N/A	Flare Type LT	N/A	N/A	Flare Type RT	N/A
N/A	Flare Slope LT (%)	N/A	N/A	Flare Slope RT (%)	0.0
N/A	Flare Traversable LT?	N/A	N/A	Flare Traversable RT?	N/A
N/A	Landing Length (in)	0.0	N/A	DWS Provided?	N/A
N/A	Landing Width (in)	0.0	N/A	DWS Contrast?	N/A
N/A	Landing Slope (%)	0.0	N/A	DWS Length (in)	N/A
N/A	Landing X Slope (%)	0.0	N/A	DWS Full Width?	N/A
N/A	Landing Curb? (Y/N)	N/A	N/A	DWS Offset LT (in)	N/A
N/A	Shared Landing?	N/A	N/A	DWS Offset RT (in)	N/A
N/A	Gutter Ponding?	0.0	N/A	Gutter Slope (%)	N/A
N/A	Gutter Lip Ht (in)	0.0	N/A	Gutter X Slope (%)	N/A
N/A	Painted X Walk1?	No		Road Slope (%)	0.4
	X Walk 1 Direction	To W		Road X Slope (%)	2.5
	X Walk 1 Width (in)	N/A		Clear Space?	N/A

X Walk 1 Slope (%)	0.4	N/A	Clear Space to XWalk (in)	N/A
	X Walk 1 X Slope (%)	2.5	N/A	Storm Grate/Utility Hazard?	N/A
N/A	Ramp inside XWalk1?	N/A		Storm Grate/Utility Type	
N/A	Any Obstructions?	N/A			N/A
	Obstruction Type		Yes	Surface Condition? (G/P)	Good
			N/A	Curb Slope (%)	19.1

Remove & Replace Entire Ramp.
