Access Compliance Report Public Rights-of-Way (Curb Ramps)

Intersection ID: 6927 Main Street: BACK_CREEK_DR Cross Street: UNIVERSITY_EAST_DR Location: S

ADA ID: 219F7B2389B2 Ramp Type: PerpDiag Initial Pass/Fail: Fail Overall Compliance: No Severity Score: 13.75

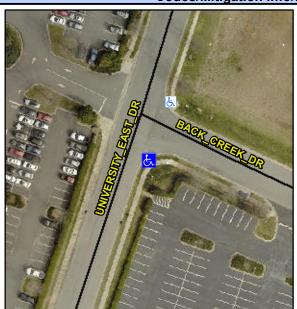
Compliance Description <u>Data</u> Compliance Description Data No Ramp Slope (%) N/A Ramp Length (in) 47.0 9.4 No Ramp XSlope (%) Yes Ramp Width (in) 55.5 3.3 N/A N/A Flare Type LT N/A Flare Type RT N/A N/A N/A N/A Flare Slope RT (%) N/A Flare Slope LT (%) N/A Flare Traversable LT? N/A N/A Flare Traversable RT? N/A N/A N/A N/A DWS Provided? N/A Landing Length (in) N/A Landing Width (in) N/A N/A **DWS Contrast?** N/A N/A N/A N/A Landing Slope (%) DWS Length (in) N/A N/A Landing X Slope (%) N/A N/A DWS Full Width? N/A N/A Landing Curb? (Y/N) N/A N/A DWS Offset (in) N/A N/A N/A Shared Landing? N/A **Gutter Ponding?** N/A N/A Gutter Slope (%) N/A N/A Gutter Lip Ht (in) N/A N/A Gutter X Slope (%) N/A N/A Painted X Walk1? No N/A Painted X Walk2? No X Walk 1 Direction To NE X Walk 2 Direction To NW N/A N/A X Walk 1 Width (in) X Walk 2 Width (in) N/A X Walk 1 Slope (%) 2.5 X Walk 2 Slope (%) 4.5 X Walk 1 X Slope (%) 3.4 X Walk 2 X Slope (%) 0.7 N/A N/A N/A Ramp inside XWalk2? N/A Ramp inside XWalk1? Road Slope (%) 1.8 N/A Clear Space? N/A N/A Road X Slope (%) 3.1 Clear Space to XWalk (in) N/A

Remove & Replace Curb Ramp With
Two New Directional Ramps or
Equivalent.
