Access Compliance Report

Public Rights-of-Way

(Curb Ramps)

Intersection ID: 10624	Main Street: STATE_ST	Cross Street: SUMTER_AV	Location: SW
ADA ID: 21A0EA3E9F5B	Ramp Type: PerpDiag	Initial Pass/Fail: Fail	Overall Compliance: No
		Severity Score: 8.75

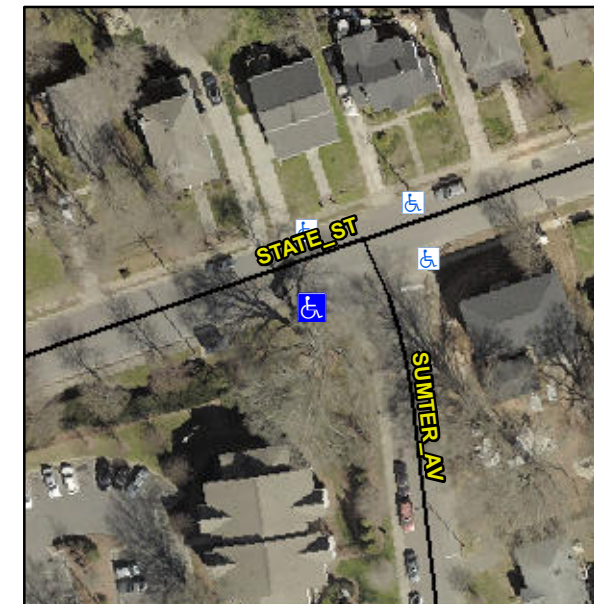
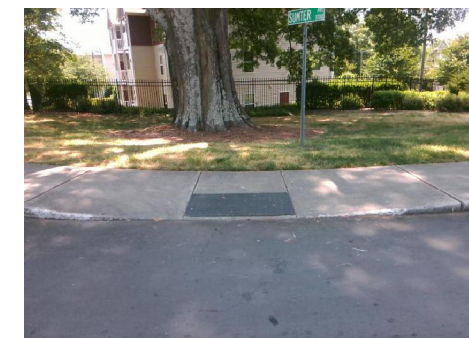
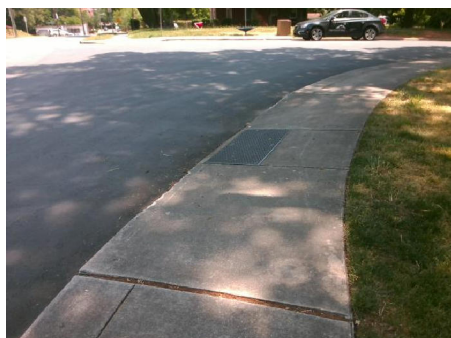
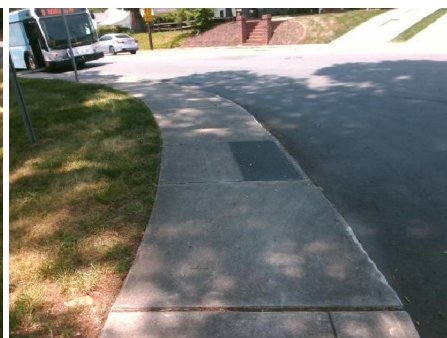
Compliance	Description	Data	Compliance	Description	Data
N/A	Ramp Length (in)	59.5	Yes	Ramp Slope (%)	8.0
No	Ramp Width (in)	45.5	Yes	Ramp XSlope (%)	0.4
N/A	Flare Type LT	N/A	N/A	Flare Type RT	N/A
N/A	Flare Slope LT (%)	N/A	N/A	Flare Slope RT (%)	N/A
N/A	Flare Traversable LT?	N/A	N/A	Flare Traversable RT?	N/A
N/A	Landing Length (in)	N/A	N/A	DWS Provided?	N/A
N/A	Landing Width (in)	N/A	N/A	DWS Contrast?	N/A
N/A	Landing Slope (%)	N/A	N/A	DWS Length (in)	N/A
N/A	Landing X Slope (%)	N/A	N/A	DWS Full Width?	N/A
N/A	Landing Curb? (Y/N)	N/A	N/A	DWS Offset (in)	N/A
N/A	Shared Landing?	N/A			
N/A	Gutter Ponding?	N/A	N/A	Gutter Slope (%)	N/A
N/A	Gutter Lip Ht (in)	N/A	N/A	Gutter X Slope (%)	N/A
N/A	Painted X Walk1?	No	N/A	Painted X Walk2?	No
	X Walk 1 Direction	To E		X Walk 2 Direction	To N
N/A	X Walk 1 Width (in)	N/A	N/A	X Walk 2 Width (in)	N/A
	X Walk 1 Slope (%)	3.4		X Walk 2 Slope (%)	0.5
	X Walk 1 X Slope (%)	1.3		X Walk 2 X Slope (%)	2.6

N/A	Ramp inside XWalk1?	N/A	N/A	Ramp inside XWalk2?	N/A
	Road Slope (%)	1.2	N/A	Clear Space?	N/A
	Road X Slope (%)	2.0	N/A	Clear Space to XWalk (in)	N/A
N/A	Any Obstructions?	N/A	N/A	Storm Grate/Utility Hazard?	N/A
	Obstruction Type			Storm Grate/Utility Type	
		N/A			N/A
			Yes	Surface Condition? (G/P)	Good

Remove & Replace Curb Ramp With Two New Directional Ramps or Equivalent.

R304.5.1
