Access Compliance Report

Public Rights-of-Way

(Curb Ramps)

| Intersection ID: 10527 | Main Street: PARKWAY_AV | Cross Street: TUCKASEEGEE_RD | Location: SW |

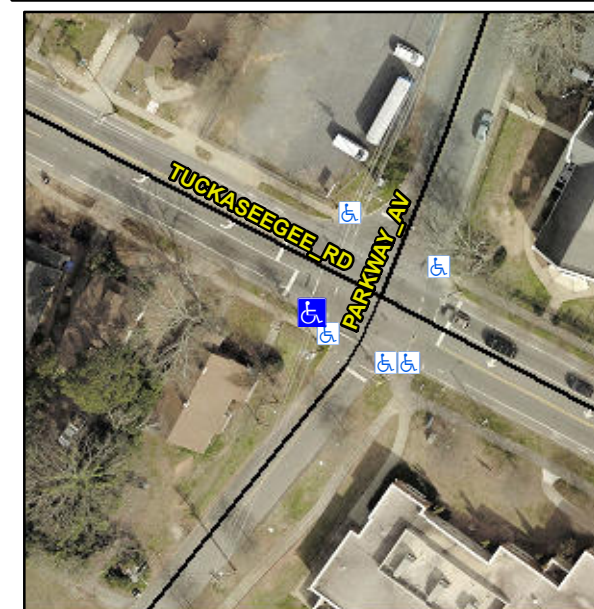
| ADA ID: 21B7AB6E5499 | Ramp Type: Directional1 | Initial Pass/Fail: Fail | Overall Compliance: No |
| Severity Score: 35 | | | |

R304.5.1, R304.2.2, R304.5.3

| Compliance | Description | Data | Compliance | Description | Data |
|---|---|---|---|---|---|
| No | Ramp Width (in) | 47.5 | N/A | Grade Break Slope (%) | 0.0 |
| No | Ramp Slope (%) | 12.1 | N/A | Grade Break XSlope (%) | 0.0 |
| No | Ramp XSlope (%) | 3.6 | | | |

Possible Solutions:

Remove & Replace Entire Ramp.
