Access Compliance Report Public Rights-of-Way (Curb Ramps)

Intersection ID: 42646 Main Street: E_4TH_ST Cross Street: S_TORRENCE_ST Location: W

ADA ID: 21BAA305296E Ramp Type: PerpDiag Initial Pass/Fail: Fail Overall Compliance: No Severity Score: 12.5

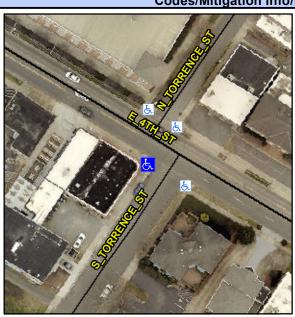
Comp	liance Description	Data	Comp	liance Description	Data
N/A	Ramp Length (in)	48.0	No	Ramp Slope (%)	10.8
Yes	Ramp Width (in)	48.0	Yes	Ramp XSlope (%)	1.5
N/A	Flare Type LT	N/A	N/A	Flare Type RT	N/A
N/A	Flare Slope LT (%)	N/A	N/A	Flare Slope RT (%)	N/A
N/A	Flare Traversable LT?	N/A	N/A	Flare Traversable RT?	N/A
N/A	Landing Length (in)	N/A	N/A	DWS Provided?	N/A
N/A	Landing Width (in)	N/A	N/A	DWS Contrast?	N/A
N/A	Landing Slope (%)	N/A	N/A	DWS Length (in)	N/A
N/A	Landing X Slope (%)	N/A	N/A	DWS Full Width?	N/A
N/A	Landing Curb? (Y/N)	N/A	N/A	DWS Offset (in)	N/A
N/A	Shared Landing?	N/A			
N/A	Gutter Ponding?	N/A	N/A	Gutter Slope (%)	N/A
N/A	Gutter Lip Ht (in)	N/A	N/A	Gutter X Slope (%)	N/A
N/A	Painted X Walk1?	No	N/A	Painted X Walk2?	No
	X Walk 1 Direction	To SE		X Walk 2 Direction	To NE
N/A	X Walk 1 Width (in)	N/A	N/A	X Walk 2 Width (in)	N/A
	X Walk 1 Slope (%)	5.5		X Walk 2 Slope (%)	0.3
	X Walk 1 X Slope (%)	2.1		X Walk 2 X Slope (%)	4.6

N/A	Ramp inside XWalk1?	N/A	N/A	Ramp inside XWalk2?	N/A
	Road Slope (%)	4.3	N/A	Clear Space?	N/A
	Road X Slope (%)	4.0	N/A	Clear Space to XWalk (in)	N/A
N/A	Any Obstructions?	N/A	N/A	Storm Grate/Utility Hazard?	N/A
	Obstruction Type			Storm Grate/Utility Type	
		N/A			N/A
			Yes	Surface Condition? (G/P)	Good

Remove & Replace Curb Ramp With Two New Directional Ramps or Equivalent.

Not Found, R304.2.2

Total Cost: \$ 3200.00
