Access Compliance Report

Public Rights-of-Way

(Curb Ramps)

Intersection ID: 8239	Main Street: STATESVILLE_AV	Cross Street: WHITTINGTON_ST	Location: SE
ADA ID: 21BD2EB8D439	Ramp Type: Perp	Initial Pass/Fail: Fail	Overall Compliance: No
			Severity Score: 13.75

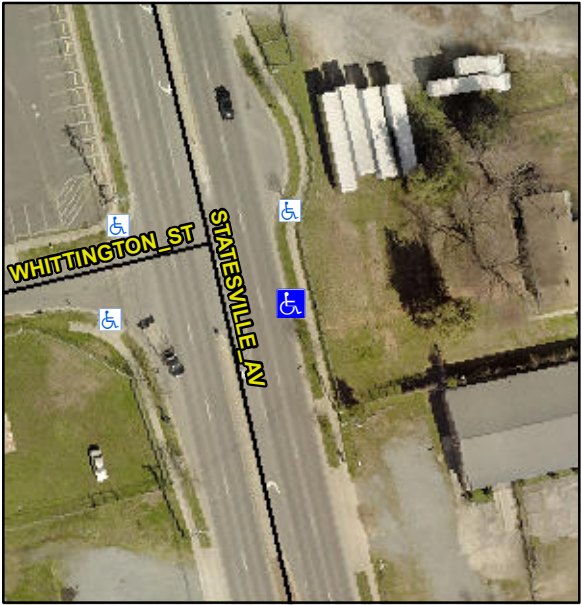
Possible Solutions:		Compliance	Description	Data
	Remove & Replace Entire Ramp.		No	Ramp Slope (%)	9.9
			Yes	Ramp Width (in)	2.4
			N/A	Flare Type LT	N/A
			N/A	Flare Slope LT (%)	N/A
			N/A	Flare Traversable LT?	N/A
			N/A	Landing Length (in)	N/A
			N/A	Landing Width (in)	N/A
			N/A	Landing Slope (%)	N/A
			N/A	Landing X Slope (%)	N/A
<p>Surveyor Notes:</p> <p>N/A</p> <p>PROW/ADA:</p> <p>Not Found, R304.2.2</p>			N/A	Flare Type RT	N/A
			N/A	Flare Slope RT (%)	N/A
			N/A	Flare Traversable RT?	N/A
			N/A	DWS Provided?	N/A
			N/A	DWS Contrast?	N/A
			N/A	DWS Length (in)	N/A
			N/A	DWS Full Width?	N/A
			N/A	DWS Offset (in)	N/A
			N/A	Shared Landing?	N/A
			N/A	Gutter Ponding?	N/A
			N/A	Gutter Lip Ht (in)	N/A
			No	Painted X Walk1?	N/A
			To W	X Walk 2 Direction	N/A
			N/A	X Walk 2 Width (in)	N/A

0.6	X Walk 2 Slope (%)	N/A
			2.9	X Walk 2 X Slope (%)	N/A
			N/A	Ramp inside XWalk1?	N/A
			N/A	Ramp inside XWalk2?	N/A
			N/A	Clear Space?	N/A
			N/A	Clear Space to XWalk (in)	N/A
			N/A	Storm Grate/Utility Hazard?	N/A
			N/A	Storm Grate/Utility Type	N/A
			N/A		N/A
			Yes	Surface Condition? (G/P)	Good
Total Cost:		\$ 1850.00
