Access Compliance Report

Public Rights-of-Way

(Curb Ramps)

Intersection ID: 13404	Main Street: LEXINGTON_AV	Cross Street: SOUTH_BV	Location: SE
ADA ID: 21BE30E1AEF6	Ramp Type: Perp	Initial Pass/Fail: Fail	Overall Compliance: No
		Severity Score: 12.5

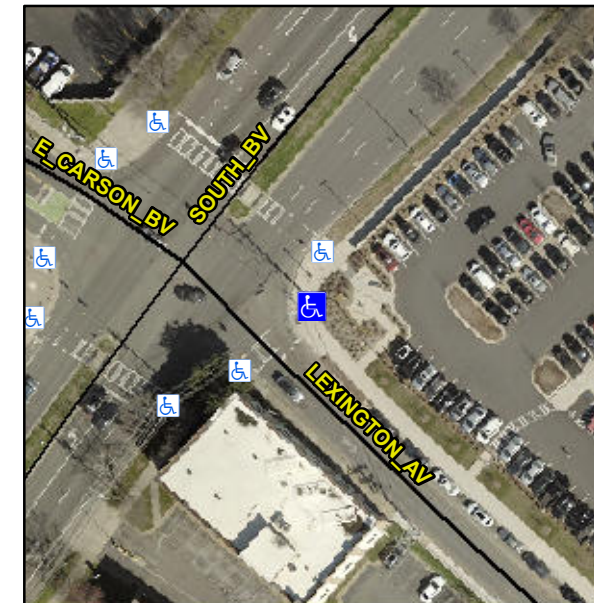
Not Found, R304.2.2

Compliance	Description	Data	Compliance	Description	Data
N/A	Ramp Length (in)	63.0	No	Ramp Slope (%)	8.6
Yes	Ramp Width (in)	64.0	Yes	Ramp XSlope (%)	0.8
N/A	Flare Type LT	N/A	N/A	Flare Type RT	N/A
N/A	Flare Slope LT (%)	N/A	N/A	Flare Slope RT (%)	N/A
N/A	Flare Traversable LT?	N/A	N/A	Flare Traversable RT?	N/A
N/A	Landing Length (in)	N/A	N/A	DWS Provided?	N/A
N/A	Landing Width (in)	N/A	N/A	DWS Contrast?	N/A
N/A	Landing Slope (%)	N/A	N/A	DWS Length (in)	N/A
N/A	Landing X Slope (%)	N/A	N/A	DWS Full Width?	N/A
N/A	Landing Curb? (Y/N)	N/A	N/A	DWS Offset (in)	N/A
N/A	Shared Landing?	N/A			
N/A	Gutter Ponding?	N/A	N/A	Gutter Slope (%)	N/A
N/A	Gutter Lip Ht (in)	N/A	N/A	Gutter X Slope (%)	N/A
N/A	Painted X Walk1?	Yes	N/A	Painted X Walk2?	N/A
	X Walk 1 Direction	To SW		X Walk 2 Direction	N/A
N/A	X Walk 1 Width (in)	112.0	N/A	X Walk 2 Width (in)	N/A
	X Walk 1 Slope (%)	1.4		X Walk 2 Slope (%)	N/A
	X Walk 1 X Slope (%)	0.6		X Walk 2 X Slope (%)	N/A

Remove & Replace Entire Ramp.
