# Access Compliance Report

## Public Rights-of-Way

### (Curb Ramps)

| Intersection ID: 7546 | Main Street: BILMARK_AV | Cross Street: ECHO_GLEN_RD | Location: E |

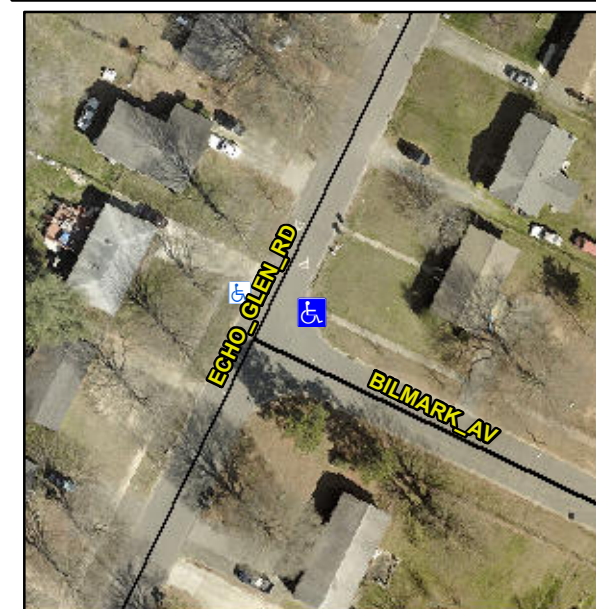
**Not Found, R304.2.1, R304.2.2-Perp,  
R304.3.2-Para, R304.5.3, R305.1.4,  
R305.2, R302.7, R304.5.4**

| Compliance | Description | Data | Compliance | Description | Data |
|---|---|---|---|---|---|
| No | Landing Length (in) | 27.0 | Yes | DWS Provided? | Yes |
| No | Landing Slope (%) | 2.7 | Yes | DWS Length (in) | 24.0 |
| No | Landing X Slope (%) | 2.4 | No | DWS Full Width? | No |
| No | Gutter Ponding? | Yes | No | Gutter Slope (%) | 19.6 |
| Yes | Gutter Lip Ht (in) | 0.0 | No | Gutter X Slope (%) | 2.1 |

**Remove & Replace Entire Ramp.  
Remove & Replace Gutter.**

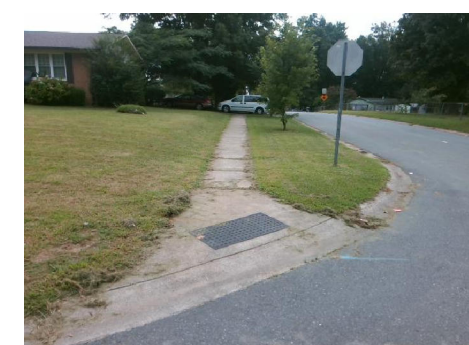
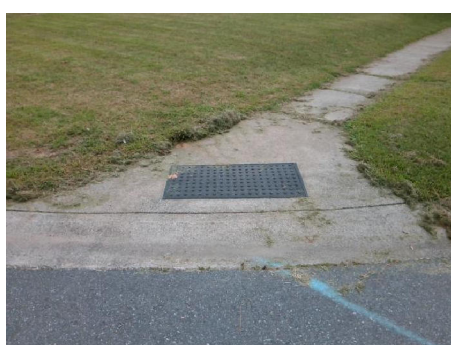
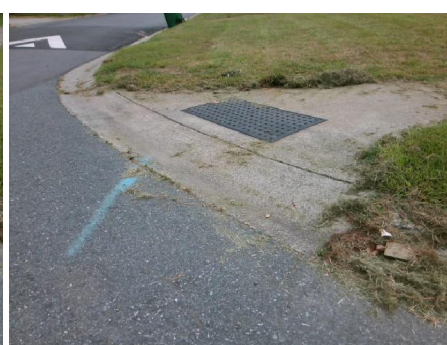
| Compliance | Description | Data | Compliance | Description | Data |
|---|---|---|---|---|---|
| | | | Yes | Surface Condition? (G/P) | Good |
