# Access Compliance Report

## Public Rights-of-Way

### (Curb Ramps)

Intersection ID: 14579	Main Street: BASIN_ST	Cross Street: S_TRYON_ST	Location: NW
ADA ID: 21D1F3ECD390	Ramp Type: ParaDiag	Initial Pass/Fail: Fail	Overall Compliance: No
Severity Score: 13.75			
Codes/Mitigation Info/Possible Solution		Field Measurements/Component Compliance

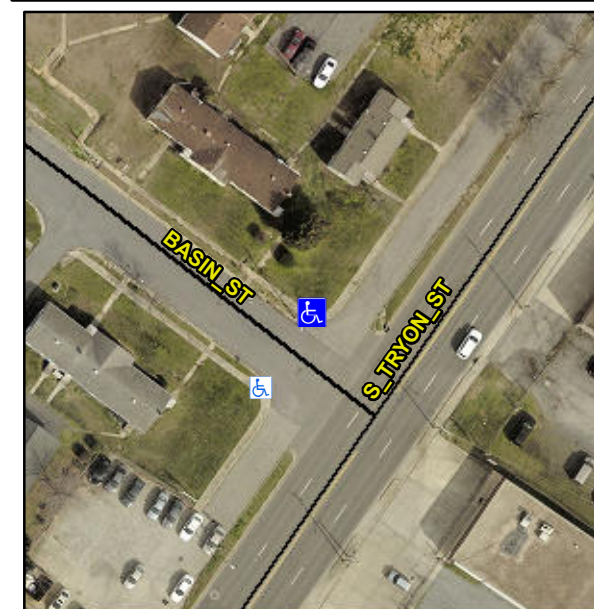
**LT RP < 5%**

**R304.5.3, R304.3.2**

Compliance	Description	Data	Compliance	Description	Data
N/A	Ramp Length LT (in)	48.0	N/A	Ramp Length RT (in)	57.0
Yes	Ramp Width LT (in)	60.0	Yes	Ramp Width RT (in)	48.0
Yes	Ramp Slope LT (%)	1.6	No	Ramp Slope RT (%)	11.9
No	Ramp XSlope LT (%)	4.1	No	Ramp XSlope RT (%)	2.1
N/A	Landing Length (in)	N/A	N/A	DWS Provided?	N/A
N/A	Landing Width (in)	N/A	N/A	DWS Contrast?	N/A
N/A	Landing Slope (%)	N/A	N/A	DWS Length (in)	N/A
N/A	Landing X Slope (%)	N/A	N/A	DWS Full Width?	N/A
N/A	Landing Curb? (Y/N)	N/A	N/A	DWS Offset (in)	N/A
N/A	Shared Landing?	N/A			
N/A	Gutter Ponding?	N/A	N/A	Gutter Slope (%)	N/A
N/A	Gutter Lip Ht (in)	N/A	N/A	Gutter X Slope (%)	N/A
N/A	Painted X Walk1?	No	N/A	Painted X Walk2?	No
	X Walk 1 Direction	To SW		X Walk 2 Direction	To SE
N/A	X Walk 1 Width (in)	N/A	N/A	X Walk 2 Width (in)	N/A
	X Walk 1 Slope (%)	1.6		X Walk 2 Slope (%)	5.4
	X Walk 1 X Slope (%)	5.3		X Walk 2 X Slope (%)	3.5
N/A	Ramp inside XWalk1?	N/A	N/A	Ramp inside XWalk2?	N/A

Road Slope (%)	6.4	N/A	Clear Space?	N/A
	Road X Slope (%)	2.8	N/A	Clear Space to XWalk (in)	N/A
N/A	Any Obstructions?	N/A	N/A	Storm Grate/Utility Hazard?	N/A
	Obstruction Type			Storm Grate/Utility Type	
		N/A			N/A
			Yes	Surface Condition? (G/P)	Good
			N/A	Curb Slope (%)	6.3

**Remove & Replace Curb Ramp With Two New Directional Ramps or Equivalent.**
