Access Compliance Report Public Rights-of-Way (Curb Ramps)

Intersection ID: 23509 Main Street: ALEXANDER_RD Cr				SUMMER DARRY IN	Location:	NE		
			Cross Street: SUMMER_DARBY_LN					
ADA ID: 21D98BF60C1B Ramp Type: PerpDiag		Initial Pa	Initial Pass/Fail: Fail Overall Compliance: No				o Severity Score:	72.5
Codes/Mitigation Info/Possible Solution			Field Measurements/Component Compliance					
	Possible Solutions:		Compliance Description			Pata Compliance Description		
	Remove & Replace Curb Ramp	With	N/A	Ramp Length (in)	48.0	No	Ramp Slope (%)	16.3
	Two New Directional Ramps or		No	Ramp Width (in)	28.0	No	Ramp XSlope (%)	6.8
	Equivalent.		N/A	Flare Type LT	N/A	N/A	Flare Type RT	N/A
			N/A	Flare Slope LT (%)	N/A	N/A	Flare Slope RT (%)	N/A
			N/A	Flare Traversable LT?	N/A	N/A	Flare Traversable RT?	N/A
			N/A	Landing Length (in)	N/A	N/A	DWS Provided?	N/A
	Surveyor Notes:		N/A	Landing Width (in)	N/A	N/A	DWS Contrast?	N/A
	N/A		N/A	Landing Slope (%)	N/A	N/A	DWS Length (in)	N/A

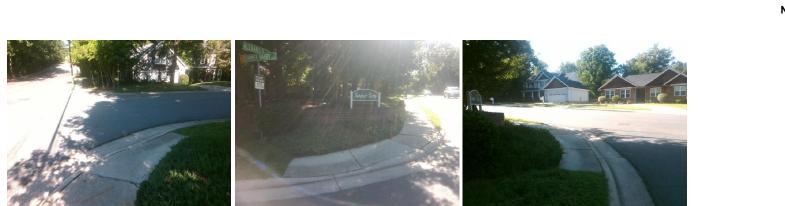
ALEXADDER LU	and the second se		N/A	Landing X Slope (%)	N/A	N/A	DWS Full Width?	N/A
the second se			N/A	Landing Curb? (Y/N)	N/A	N/A	DWS Offset (in)	N/A
	and the second s		N/A	Shared Landing?	N/A			
	PROW/ADA:		N/A	Gutter Ponding?	N/A	N/A	Gutter Slope (%)	N/A
the second second	R304.5.1, R304.2.2, R304.5.3		N/A	Gutter Lip Ht (in)	N/A	N/A	Gutter X Slope (%)	N/A
			N/A	Painted X Walk1?	No	N/A	Painted X Walk2?	No
				X Walk 1 Direction	To W		X Walk 2 Direction	To S
			N/A	X Walk 1 Width (in)	N/A	N/A	X Walk 2 Width (in)	N/A
Street 1 Name SUMMEE DA	RBY LN			X Walk 1 Slope (%)	0.7		X Walk 2 Slope (%)	7.8
Stop Condition-Street 2 St	topSign			X Walk 1 X Slope (%)	3.0		X Walk 2 X Slope (%)	2.6
Street 2 Name ALEXANI	DER RD		N/A	Ramp inside XWalk1?	N/A	N/A	Ramp inside XWalk2?	N/A
Stop Condition-Street 1	None			Road Slope (%)	3.2	N/A	Clear Space?	N/A
				Road X Slope (%)	2.5	N/A	Clear Space to XWalk (in)	N/A
			N/A	Any Obstructions?	N/A	N/A	Storm Grate/Utility Hazard?	N/A

Total Cost: \$	3200.00		Obstruction Type			Storm Grate/Utility Type	
					N/A			N/A
