# Access Compliance Report

## Public Rights-of-Way

### (Curb Ramps)

Intersection ID: 12449	Main Street: SUTTLE_AV	Cross Street: ISOM_ST	Location: SW
ADA ID: 21EB5B102F71	Ramp Type: BlendTrans2	Initial Pass/Fail: Fail	Overall Compliance: No
		Severity Score: 1.25

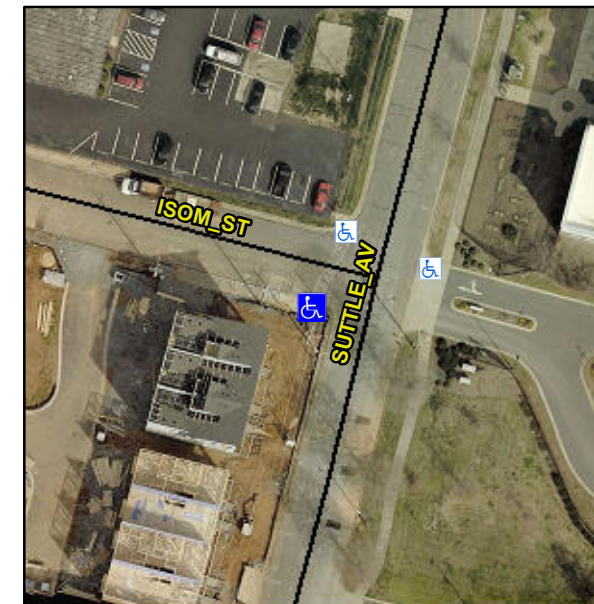
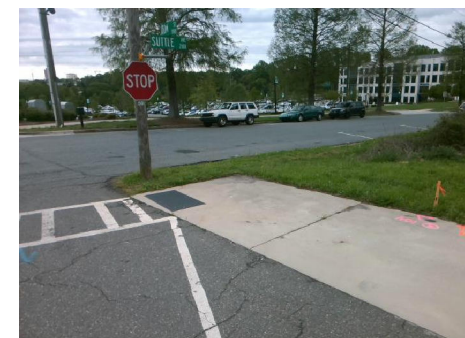
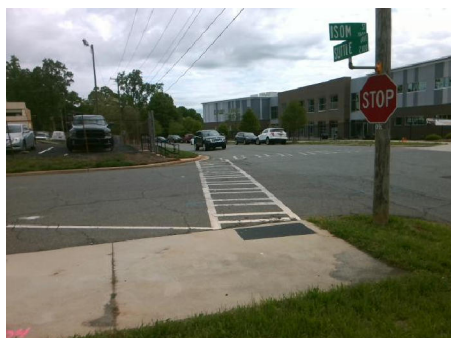
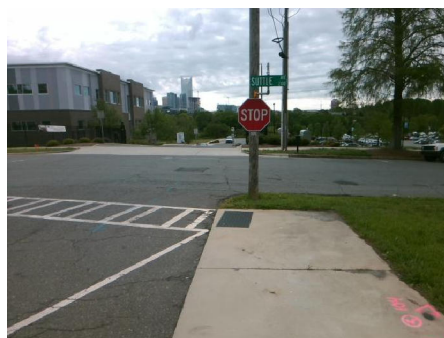
**RP IS FLAT, NO LT SW**

Compliance	Description	Data	Compliance	Description	Data
N/A	Ramp Length (in)	101.0	Yes	BlendTrans Slope (%)	1.6
Yes	Ramp Width (in)	48.0	No	BlendTrans XSlope (%)	2.2
N/A	Flare Type LT	N/A	N/A	Flare Type RT	N/A
N/A	Flare Slope LT (%)	N/A	N/A	Flare Slope RT (%)	N/A
N/A	Flare Traversable LT?	N/A	N/A	Flare Traversable RT?	N/A
N/A	Landing Length (in)	N/A	N/A	DWS Provided?	N/A
N/A	Landing Width (in)	N/A	N/A	DWS Contrast?	N/A
N/A	Landing Slope (%)	N/A	N/A	DWS Length (in)	N/A
N/A	Landing X Slope (%)	N/A	N/A	DWS Full Width?	N/A
N/A	Landing Curb? (Y/N)	N/A	N/A	DWS Offset (in)	N/A
N/A	Shared Landing?	N/A			
N/A	Gutter Ponding?	N/A	N/A	Gutter Slope (%)	N/A
N/A	Gutter Lip Ht (in)	N/A	N/A	Gutter X Slope (%)	N/A
N/A	Painted X Walk1?	Yes	N/A	Painted X Walk2?	N/A
	X Walk 1 Direction	To N		X Walk 2 Direction	N/A
	X Walk 1 Width (in)	53.0		X Walk 2 Width (in)	N/A
	X Walk 1 Slope (%)	3.4		X Walk 2 Slope (%)	N/A
	X Walk 1 X Slope (%)	2.7		X Walk 2 X Slope (%)	N/A

N/A	Ramp inside XWalk1?	Yes	N/A	Ramp inside XWalk2?	N/A
	Road Slope (%)	2.7		Clear Space?	N/A
	Road X Slope (%)	3.4	N/A	Clear Space to XWalk (in)	N/A
N/A	Any Obstructions?	N/A	N/A	Storm Grate/Utility Hazard?	N/A
	Obstruction Type			Storm Grate/Utility Type	
			N/A		N/A
			Yes	Surface Condition? (G/P)	Good
			N/A	Curb Slope (%)	0.1

**Remove & Replace Curb Ramp With Two New Directional Ramps or Equivalent.**

**R304.5.3**
