Access Compliance Report

Public Rights-of-Way

(Curb Ramps)

Intersection ID: 42533	Main Street: CASTLETOWN_HOUSE_DR	Cross Street: ROTHE_HOUSE_RD	Location: NE
ADA ID: 21ECE106A831	Ramp Type: PerpDiag	Initial Pass/Fail: Fail	Overall Compliance: No
		Severity Score: 22.5

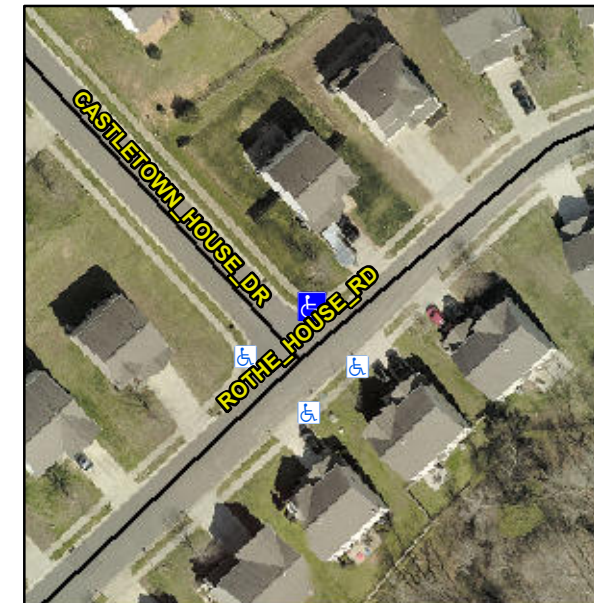
Compliance	Description	Data	Compliance	Description	Data
N/A	Ramp Length (in)	47.0	No	Ramp Slope (%)	8.5
No	Ramp Width (in)	42.5	No	Ramp XSlope (%)	4.7
N/A	Flare Type LT	N/A	N/A	Flare Type RT	N/A
N/A	Flare Slope LT (%)	N/A	N/A	Flare Slope RT (%)	N/A
N/A	Flare Traversable LT?	N/A	N/A	Flare Traversable RT?	N/A
N/A	Landing Length (in)	N/A	N/A	DWS Provided?	N/A
N/A	Landing Width (in)	N/A	N/A	DWS Contrast?	N/A
N/A	Landing Slope (%)	N/A	N/A	DWS Length (in)	N/A
N/A	Landing X Slope (%)	N/A	N/A	DWS Full Width?	N/A
N/A	Landing Curb? (Y/N)	N/A	N/A	DWS Offset (in)	N/A
N/A	Shared Landing?	N/A			
N/A	Gutter Ponding?	N/A	N/A	Gutter Slope (%)	N/A
N/A	Gutter Lip Ht (in)	N/A	N/A	Gutter X Slope (%)	N/A
N/A	Painted X Walk1?	No	N/A	Painted X Walk2?	No
	X Walk 1 Direction	To SW		X Walk 2 Direction	To SE
N/A	X Walk 1 Width (in)	N/A	N/A	X Walk 2 Width (in)	N/A
	X Walk 1 Slope (%)	1.9		X Walk 2 Slope (%)	0.8
	X Walk 1 X Slope (%)	3.4		X Walk 2 X Slope (%)	2.2

N/A	Ramp inside XWalk1?	N/A	N/A	Ramp inside XWalk2?	N/A
	Road Slope (%)	4.8	N/A	Clear Space?	N/A
	Road X Slope (%)	0.2	N/A	Clear Space to XWalk (in)	N/A
N/A	Any Obstructions?	N/A	N/A	Storm Grate/Utility Hazard?	N/A
	Obstruction Type			Storm Grate/Utility Type	
		N/A			N/A
			Yes	Surface Condition? (G/P)	Good

Remove & Replace Curb Ramp With Two New Directional Ramps or Equivalent.

R304.5.1, R304.2.2, R304.5.3
