Access Compliance Report

Public Rights-of-Way

(Curb Ramps)

| Intersection ID: 2879 | Main Street: HIGHLAND_CREEK_PY | Cross Street: RIDGE_RD | Location: | N |

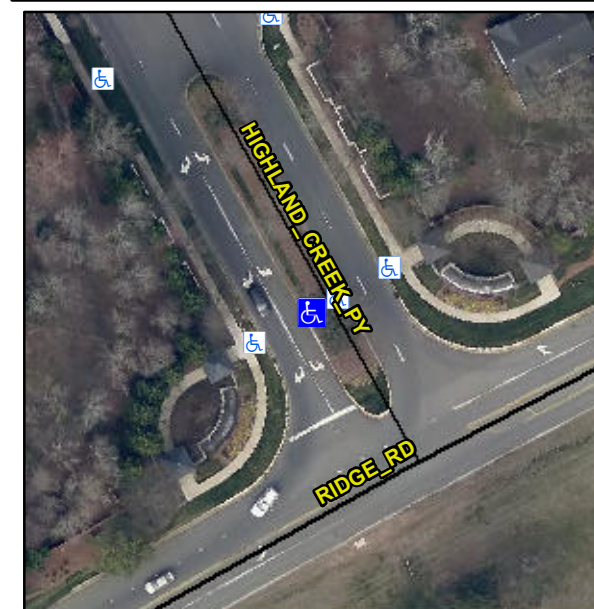
| ADA ID: 21EEA7CEC37D | Ramp Type: MedianPerp | Initial Pass/Fail: Fail | Overall Compliance: No | Severity Score: 25 |

R304.2.2

| Compliance | Description | Data | Compliance | Description | Data |
|---|---|---|---|---|---|
| N/A | Ramp Length (in) | 59.0 | No | Ramp Slope (%) | 21.9 |

Possible Solutions:

Remove & Replace Entire Ramp.
