Access Compliance Report

Public Rights-of-Way

(Curb Ramps)

Intersection ID: 47123	Main Street: THOMPSON_BROOK_LN	Cross Street: EMMONS_LN	Location: SW
ADA ID: 21EF3C9480EE	Ramp Type: PerpDiag	Initial Pass/Fail: Fail	Overall Compliance: No
Severity Score: 8.75			
Codes/Mitigation Info/Possible Solution		Field Measurements/Component Compliance

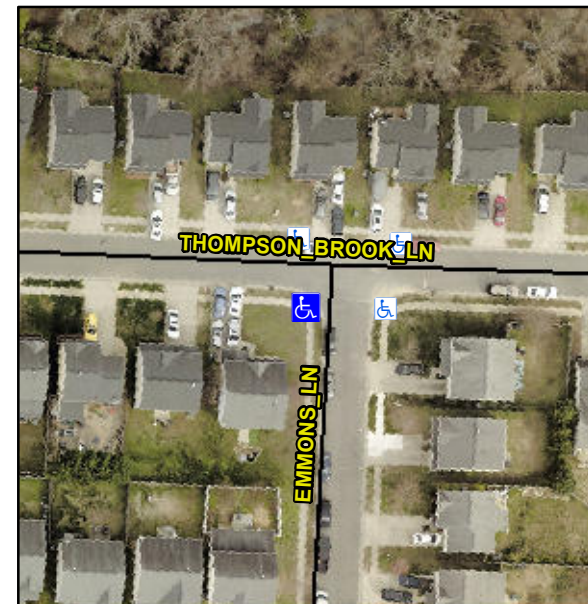
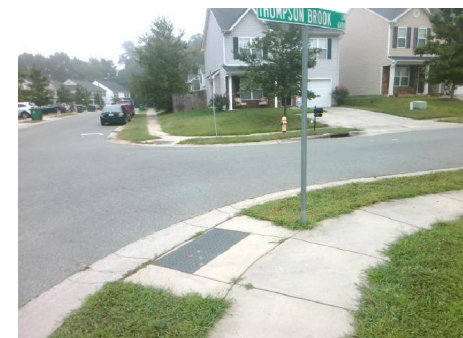
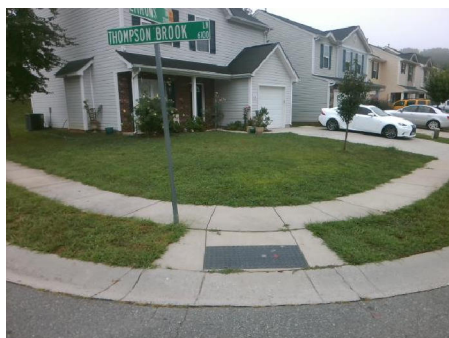
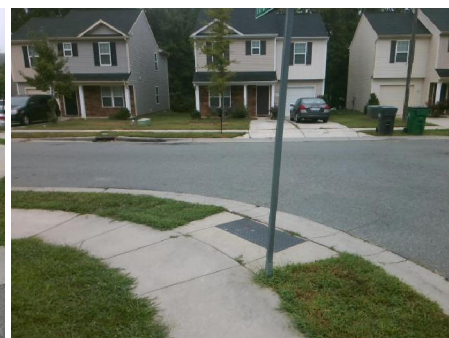
PROW/ADA:

Not Found, R304.5.1

Compliance	Description	Data	Compliance	Description	Data
N/A	Ramp Length (in)	45.0	Yes	Ramp Slope (%)	5.3
No	Ramp Width (in)	44.0	Yes	Ramp XSlope (%)	1.9
N/A	Flare Type LT	N/A	N/A	Flare Type RT	N/A
N/A	Flare Slope LT (%)	N/A	N/A	Flare Slope RT (%)	N/A
N/A	Flare Traversable LT?	N/A	N/A	Flare Traversable RT?	N/A
N/A	Landing Length (in)	N/A	N/A	DWS Provided?	N/A
N/A	Landing Width (in)	N/A	N/A	DWS Contrast?	N/A
N/A	Landing Slope (%)	N/A	N/A	DWS Length (in)	N/A
N/A	Landing X Slope (%)	N/A	N/A	DWS Full Width?	N/A
N/A	Landing Curb? (Y/N)	N/A	N/A	DWS Offset (in)	N/A
N/A	Shared Landing?	N/A			
N/A	Gutter Ponding?	N/A	N/A	Gutter Slope (%)	N/A
N/A	Gutter Lip Ht (in)	N/A	N/A	Gutter X Slope (%)	N/A
N/A	Painted X Walk1?	No	N/A	Painted X Walk2?	No
	X Walk 1 Direction	To SE		X Walk 2 Direction	To NE
N/A	X Walk 1 Width (in)	N/A	N/A	X Walk 2 Width (in)	N/A
	X Walk 1 Slope (%)	2.3		X Walk 2 Slope (%)	1.1
	X Walk 1 X Slope (%)	0.5		X Walk 2 X Slope (%)	0.8

N/A	Ramp inside XWalk1?	N/A	N/A	Ramp inside XWalk2?	N/A
	Road Slope (%)	0.9	N/A	Clear Space?	N/A
	Road X Slope (%)	1.4	N/A	Clear Space to XWalk (in)	N/A
N/A	Any Obstructions?	N/A	N/A	Storm Grate/Utility Hazard?	N/A
	Obstruction Type			Storm Grate/Utility Type	
		N/A			N/A
			Yes	Surface Condition? (G/P)	Good

Possible Solutions:

Remove & Replace Curb Ramp With Two New Directional Ramps or Equivalent.
