Access Compliance Report

Public Rights-of-Way

(Curb Ramps)

Intersection ID: N/A	Main Street: CHOYCE_RD	Cross Street: CHOYCE_RD	Location: NE
ADA ID: 21F55943CAAA	Ramp Type: PerpDiag	Initial Pass/Fail: Fail	Overall Compliance: No
Severity Score: 22.5			
Codes/Mitigation Info/Possible Solution		Field Measurements/Component Compliance

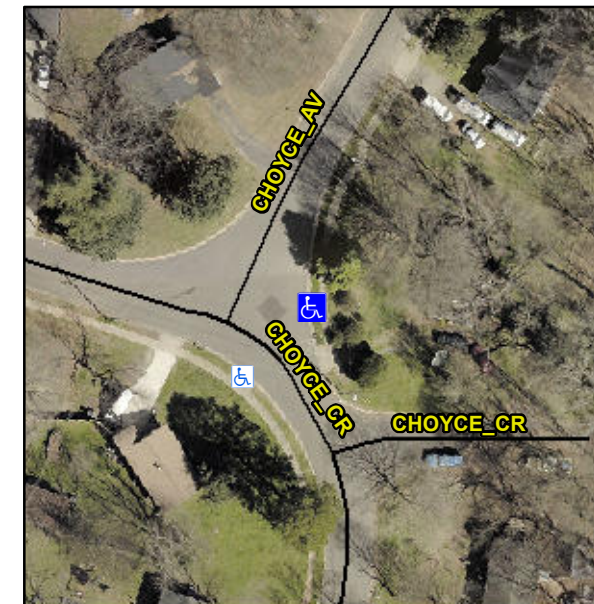
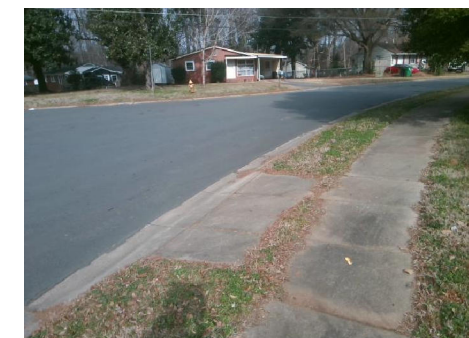
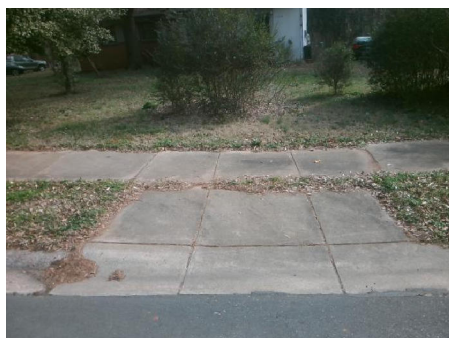
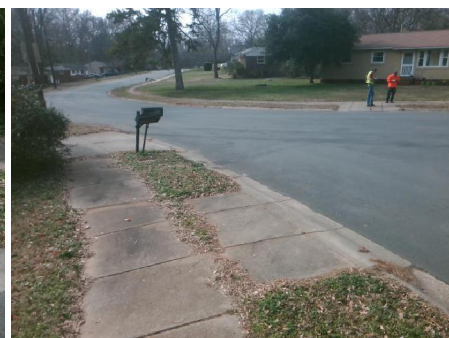
Not Found, R304.5.1, R304.2.2, R304.5.3

Compliance	Description	Data	Compliance	Description	Data
N/A	Ramp Length (in)	48.0	No	Ramp Slope (%)	9.0
No	Ramp Width (in)	46.3	No	Ramp XSlope (%)	3.5
N/A	Flare Type LT	N/A	N/A	Flare Type RT	N/A
N/A	Flare Slope LT (%)	N/A	N/A	Flare Slope RT (%)	N/A
N/A	Flare Traversable LT?	N/A	N/A	Flare Traversable RT?	N/A
N/A	Landing Length (in)	N/A	N/A	DWS Provided?	N/A
N/A	Landing Width (in)	N/A	N/A	DWS Contrast?	N/A
N/A	Landing Slope (%)	N/A	N/A	DWS Length (in)	N/A
N/A	Landing X Slope (%)	N/A	N/A	DWS Full Width?	N/A
N/A	Landing Curb? (Y/N)	N/A	N/A	DWS Offset (in)	N/A
N/A	Shared Landing?	N/A			
N/A	Gutter Ponding?	N/A	N/A	Gutter Slope (%)	N/A
N/A	Gutter Lip Ht (in)	N/A	N/A	Gutter X Slope (%)	N/A
N/A	Painted X Walk1?	No	N/A	Painted X Walk2?	No
	X Walk 1 Direction	To NW		X Walk 2 Direction	To SW
N/A	X Walk 1 Width (in)	N/A	N/A	X Walk 2 Width (in)	N/A
	X Walk 1 Slope (%)	4.3		X Walk 2 Slope (%)	0.5
	X Walk 1 X Slope (%)	0.5		X Walk 2 X Slope (%)	3.7

N/A	Ramp inside XWalk1?	N/A	N/A	Ramp inside XWalk2?	N/A
	Road Slope (%)	3.0	N/A	Clear Space?	N/A
	Road X Slope (%)	2.8	N/A	Clear Space to XWalk (in)	N/A
N/A	Any Obstructions?	N/A	N/A	Storm Grate/Utility Hazard?	N/A
	Obstruction Type			Storm Grate/Utility Type	
		N/A			N/A
			Yes	Surface Condition? (G/P)	Good

Remove & Replace Curb Ramp With Two New Directional Ramps or Equivalent.
