Access Compliance Report

Public Rights-of-Way

(Curb Ramps)

Intersection ID: 14036	Main Street: COMMONWEALTH_AV	Cross Street: MORNINGSIDE_DR	Location: S
ADA ID: 2209C32EBAD3	Ramp Type: PerpDiag	Initial Pass/Fail: Fail	Overall Compliance: No
Severity Score: 12.5			
Codes/Mitigation Info/Possible Solution		Field Measurements/Component Compliance

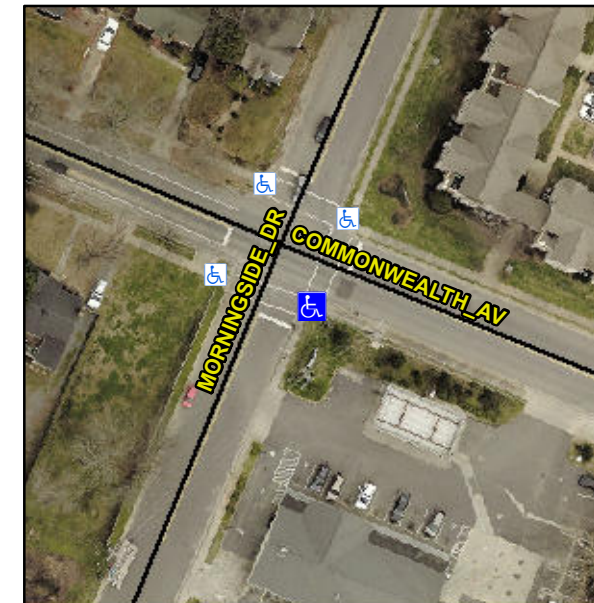
Not Found, R304.2.2

Compliance	Description	Data	Compliance	Description	Data
N/A	Ramp Length (in)	55.0	No	Ramp Slope (%)	9.1
Yes	Ramp Width (in)	48.0	Yes	Ramp XSlope (%)	0.4
N/A	Flare Type LT	N/A	N/A	Flare Type RT	N/A
N/A	Flare Slope LT (%)	N/A	N/A	Flare Slope RT (%)	N/A
N/A	Flare Traversable LT?	N/A	N/A	Flare Traversable RT?	N/A
N/A	Landing Length (in)	N/A	N/A	DWS Provided?	N/A
N/A	Landing Width (in)	N/A	N/A	DWS Contrast?	N/A
N/A	Landing Slope (%)	N/A	N/A	DWS Length (in)	N/A
N/A	Landing X Slope (%)	N/A	N/A	DWS Full Width?	N/A
N/A	Landing Curb? (Y/N)	N/A	N/A	DWS Offset (in)	N/A
N/A	Shared Landing?	N/A			
N/A	Gutter Ponding?	N/A	N/A	Gutter Slope (%)	N/A
N/A	Gutter Lip Ht (in)	N/A	N/A	Gutter X Slope (%)	N/A
N/A	Painted X Walk1?	Yes	N/A	Painted X Walk2?	Yes
	X Walk 1 Direction	To NE		X Walk 2 Direction	To NW
N/A	X Walk 1 Width (in)	109.0	N/A	X Walk 2 Width (in)	110.0
	X Walk 1 Slope (%)	4.7		X Walk 2 Slope (%)	3.8
	X Walk 1 X Slope (%)	1.8		X Walk 2 X Slope (%)	1.8

N/A	Ramp inside XWalk1?	Yes	N/A	Ramp inside XWalk2?	Yes
	Road Slope (%)	1.4	N/A	Clear Space?	N/A
	Road X Slope (%)	3.7	N/A	Clear Space to XWalk (in)	N/A
N/A	Any Obstructions?	N/A	N/A	Storm Grate/Utility Hazard?	N/A
	Obstruction Type			Storm Grate/Utility Type	
		N/A			N/A
		Yes		Surface Condition? (G/P)	Good

Remove & Replace Curb Ramp With Two New Directional Ramps or Equivalent.
