# Access Compliance Report

## Public Rights-of-Way

### (Curb Ramps)

Intersection ID: 49555	Main Street: ARTISTS_WY	Cross Street: STEEL_GARDENS_BV	Location: SE
ADA ID: 2211C5E3ABBA	Ramp Type: Perp	Initial Pass/Fail: Fail	Overall Compliance: No
Severity Score: 12.5			
Codes/Mitigation Info/Possible Solution		Field Measurements/Component Compliance

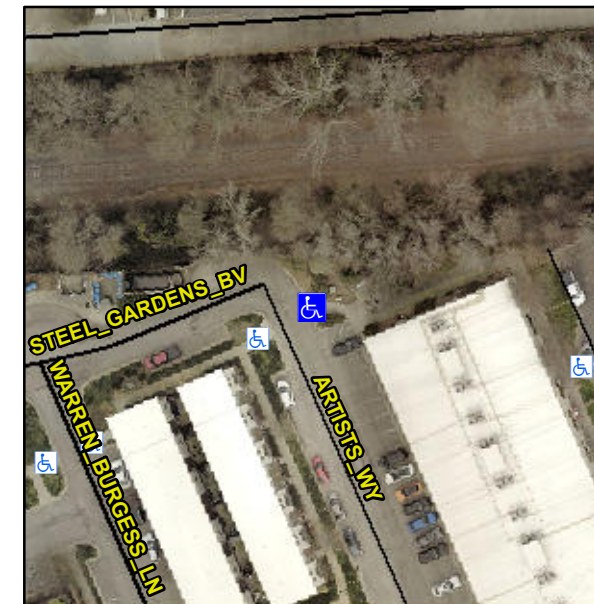
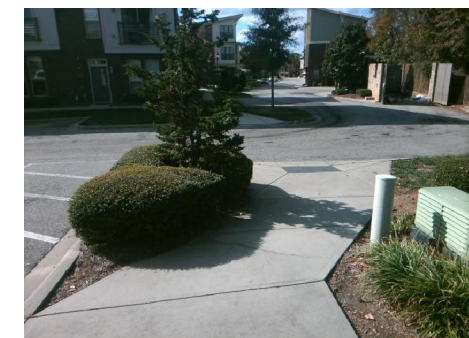
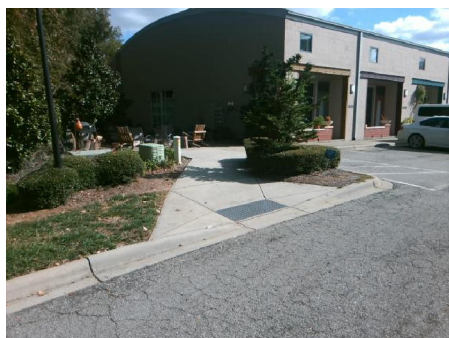
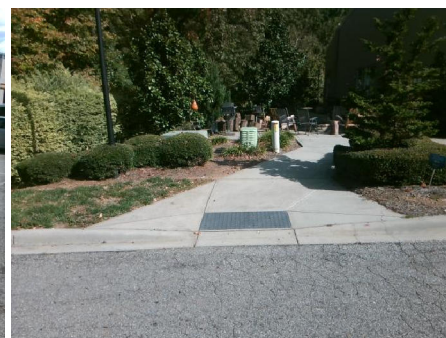
Compliance	Description	Data	Compliance	Description	Data
N/A	Ramp Length (in)	214.0	Yes	Ramp Slope (%)	10.0
Yes	Ramp Width (in)	48.0	Yes	Ramp XSlope (%)	1.8
N/A	Flare Type LT	N/A	N/A	Flare Type RT	N/A
N/A	Flare Slope LT (%)	N/A	N/A	Flare Slope RT (%)	N/A
N/A	Flare Traversable LT?	N/A	N/A	Flare Traversable RT?	N/A
N/A	Landing Length (in)	N/A	N/A	DWS Provided?	N/A
N/A	Landing Width (in)	N/A	N/A	DWS Contrast?	N/A
N/A	Landing Slope (%)	N/A	N/A	DWS Length (in)	N/A
N/A	Landing X Slope (%)	N/A	N/A	DWS Full Width?	N/A
N/A	Landing Curb? (Y/N)	N/A	N/A	DWS Offset (in)	N/A
N/A	Shared Landing?	N/A			
N/A	Gutter Ponding?	N/A	N/A	Gutter Slope (%)	N/A
N/A	Gutter Lip Ht (in)	N/A	N/A	Gutter X Slope (%)	N/A
N/A	Painted X Walk1?	No	N/A	Painted X Walk2?	N/A
	X Walk 1 Direction	To SW		X Walk 2 Direction	N/A
N/A	X Walk 1 Width (in)	N/A	N/A	X Walk 2 Width (in)	N/A
	X Walk 1 Slope (%)	2.4		X Walk 2 Slope (%)	N/A
	X Walk 1 X Slope (%)	4.6		X Walk 2 X Slope (%)	N/A

N/A	Ramp inside XWalk1?	N/A	N/A	Ramp inside XWalk2?	N/A
	Road Slope (%)	N/A	N/A	Clear Space?	N/A
	Road X Slope (%)	N/A	N/A	Clear Space to XWalk (in)	N/A
N/A	Any Obstructions?	N/A	N/A	Storm Grate/Utility Hazard?	N/A
	Obstruction Type			Storm Grate/Utility Type	
		N/A			N/A
			Yes	Surface Condition? (G/P)	Good

Possible Solutions:

**Remove & Replace Entire Ramp.**
