Access Compliance Report

Public Rights-of-Way (Curb Ramps)

Intersection ID: N/A	Main Street: ORCHID_BRIDGE_RD	Cross Street: PUMPERNICKEL_RD	Location: NE
ADA ID: 221902C53579	Ramp Type: Perp	Initial Pass/Fail: Fail	Overall Compliance: No
Codes/Mitigation Info/Possible Solution		Field Measurements/Component Compliance

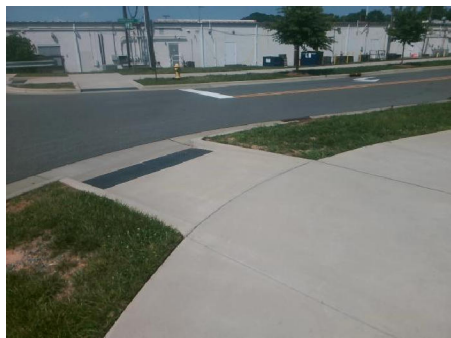
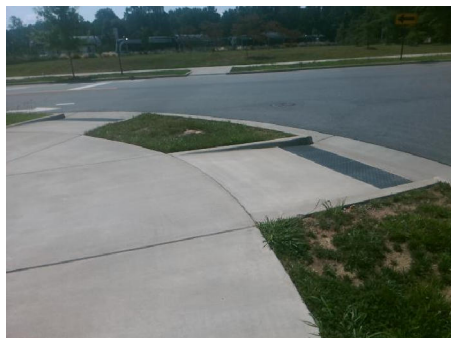
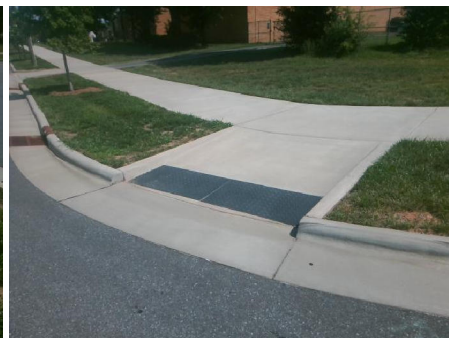
Compliance	Description	Data	Compliance	Description	Data
N/A	Ramp Length (in)	96.0	No	Ramp Slope (%)	9.5
Yes	Ramp Width (in)	90.0	No	Ramp XSlope (%)	2.5
N/A	Flare Type LT	N/A	N/A	Flare Type RT	N/A
N/A	Flare Slope LT (%)	N/A	N/A	Flare Slope RT (%)	N/A
N/A	Flare Traversable LT?	N/A	N/A	Flare Traversable RT?	N/A
N/A	Landing Length (in)	N/A	N/A	DWS Provided?	N/A
N/A	Landing Width (in)	N/A	N/A	DWS Contrast?	N/A
N/A	Landing Slope (%)	N/A	N/A	DWS Length (in)	N/A
N/A	Landing X Slope (%)	N/A	N/A	DWS Full Width?	N/A
N/A	Landing Curb? (Y/N)	N/A	N/A	DWS Offset (in)	N/A
N/A	Shared Landing?	N/A			
N/A	Gutter Ponding?	N/A	N/A	Gutter Slope (%)	N/A
N/A	Gutter Lip Ht (in)	N/A	N/A	Gutter X Slope (%)	N/A
N/A	Painted X Walk1?	No	N/A	Painted X Walk2?	N/A
	X Walk 1 Direction	To SW		X Walk 2 Direction	N/A
N/A	X Walk 1 Width (in)	N/A	N/A	X Walk 2 Width (in)	N/A
	X Walk 1 Slope (%)	2.1		X Walk 2 Slope (%)	N/A
	X Walk 1 X Slope (%)	1.6		X Walk 2 X Slope (%)	N/A

N/A	Ramp inside XWalk1?	N/A	N/A	Ramp inside XWalk2?	N/A
	Road Slope (%)	N/A	N/A	Clear Space?	N/A
	Road X Slope (%)	N/A	N/A	Clear Space to XWalk (in)	N/A
N/A	Any Obstructions?	N/A	N/A	Storm Grate/Utility Hazard?	N/A
	Obstruction Type			Storm Grate/Utility Type	
		N/A			N/A
			Yes	Surface Condition? (G/P)	Good

Remove & Replace Entire Ramp.
