# Access Compliance Report

## Public Rights-of-Way

Intersection ID: 13357	Main Street: FABER_ST	Cross Street: SEYMOUR_DR	Location: NW
ADA ID: 222C4004B193	Ramp Type: ParaDiag	Initial Pass/Fail: Fail	Overall Compliance: No
		Severity Score: 22.5

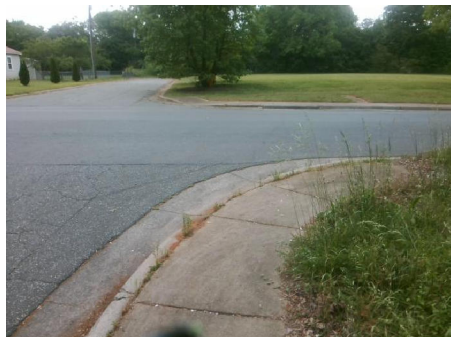
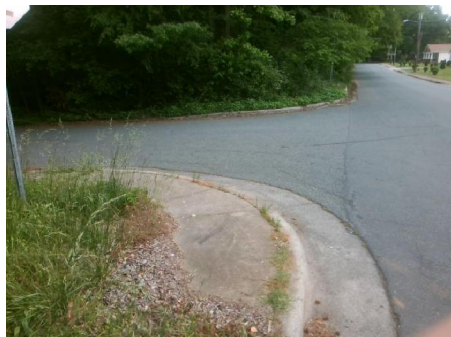
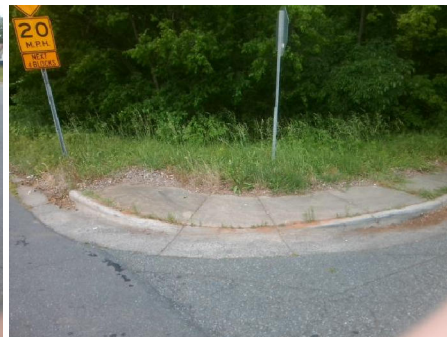
**RT RP < 5%**

Compliance	Description	Data	Compliance	Description	Data
N/A	Ramp Length LT (in)	68.0	N/A	Ramp Length RT (in)	48.0
No	Ramp Width LT (in)	41.0	No	Ramp Width RT (in)	45.0
No	Ramp Slope LT (%)	10.6	Yes	Ramp Slope RT (%)	3.3
No	Ramp XSlope LT (%)	3.2	No	Ramp XSlope RT (%)	3.5
N/A	Landing Length (in)	N/A	N/A	DWS Provided?	N/A
N/A	Landing Width (in)	N/A	N/A	DWS Contrast?	N/A
N/A	Landing Slope (%)	N/A	N/A	DWS Length (in)	N/A
N/A	Landing X Slope (%)	N/A	N/A	DWS Full Width?	N/A
N/A	Landing Curb? (Y/N)	N/A	N/A	DWS Offset (in)	N/A
N/A	Shared Landing?	N/A			
N/A	Gutter Ponding?	N/A	N/A	Gutter Slope (%)	N/A
N/A	Gutter Lip Ht (in)	N/A	N/A	Gutter X Slope (%)	N/A
N/A	Painted X Walk1?	No	N/A	Painted X Walk2?	No
	X Walk 1 Direction	To S		X Walk 2 Direction	To E
N/A	X Walk 1 Width (in)	N/A	N/A	X Walk 2 Width (in)	N/A
	X Walk 1 Slope (%)	4.8		X Walk 2 Slope (%)	2.4
	X Walk 1 X Slope (%)	0.5		X Walk 2 X Slope (%)	7.7
N/A	Ramp inside XWalk1?	N/A	N/A	Ramp inside XWalk2?	N/A

Road Slope (%)	5.7	N/A	Clear Space?	N/A
	Road X Slope (%)	3.9	N/A	Clear Space to XWalk (in)	N/A
N/A	Any Obstructions?	N/A	N/A	Storm Grate/Utility Hazard?	N/A
	Obstruction Type			Storm Grate/Utility Type	
		N/A			N/A
			Yes	Surface Condition? (G/P)	Good
			N/A	Curb Slope (%)	11.3

**Remove & Replace Curb Ramp With Two New Directional Ramps or Equivalent.**
