## Access Compliance Report Public Rights-of-Way (Curb Ramps)

Intersection ID: 12882 Main Street: CRESTMONT\_DR Cross Street: SUDBURY\_RD Location: N

ADA ID: 222FD1BD3BC1 Ramp Type: Perp Initial Pass/Fail: Fail Overall Compliance: No Severity Score: 10

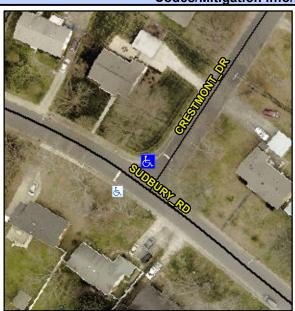
Not Found, R304.5.1

N/A	Ramp Length (in)	69.5	Yes	Ramp Slope (%)
No	Ramp Width (in)	44.0	Yes	Ramp XSlope (%)
N/A	Flare Type LT	N/A	N/A	Flare Type RT
N/A	Flare Slope LT (%)	N/A	N/A	Flare Slope RT (%)
N/A	Flare Traversable LT?	N/A	N/A	Flare Traversable RT?
N/A	Landing Length (in)	N/A	N/A	DWS Provided?
N/A	Landing Width (in)	N/A	N/A	DWS Contrast?
N/A	Landing Slope (%)	N/A	N/A	DWS Length (in)
N/A	Landing X Slope (%)	N/A	N/A	DWS Full Width?
N/A	Landing Curb? (Y/N)	N/A	N/A	DWS Offset (in)
N/A	Shared Landing?	N/A		
N/A	Gutter Ponding?	N/A	N/A	Gutter Slope (%)
N/A	Gutter Lip Ht (in)	1.5	N/A	Gutter X Slope (%)
N/A	Painted X Walk1?	No	N/A	Painted X Walk2?
	X Walk 1 Direction	To SW		X Walk 2 Direction
N/A	X Walk 1 Width (in)	N/A	N/A	X Walk 2 Width (in)
	X Walk 1 Slope (%)	0.0		X Walk 2 Slope (%)
	X Walk 1 X Slope (%)	4.0		X Walk 2 X Slope (%)
N/A	Ramp inside XWalk1?	N/A	N/A	Ramp inside XWalk2?
	Road Slope (%)	N/A	N/A	Clear Space?
	Road X Slope (%)	N/A	N/A	Clear Space to XWalk (in)

Possible Solutions:

Remove & Replace Entire Ramp.

Total Cost: \$ 1850.00
