Access Compliance Report

Public Rights-of-Way

(Curb Ramps)

Intersection ID: 22899	Main Street: LAUREL_TRACE_DR	Cross Street: OAKBRIAR_LN	Location: SE
ADA ID: 22343874EC7A	Ramp Type: Perp	Initial Pass/Fail: Fail	Overall Compliance: No
Severity Score: 12.5			
Codes/Mitigation Info/Possible Solution		Field Measurements/Component Compliance

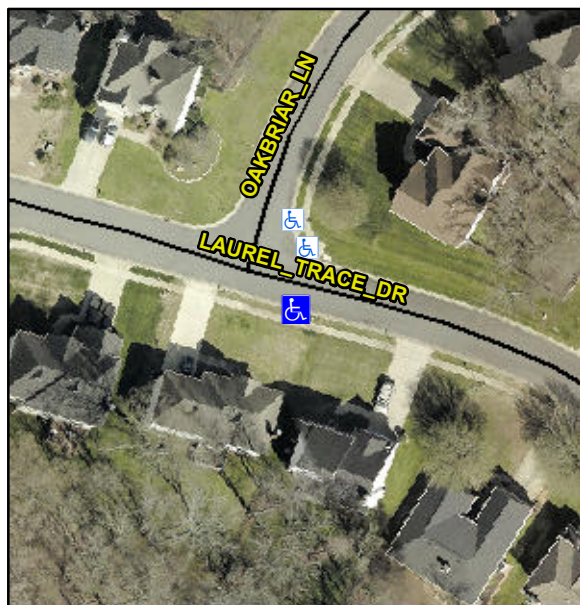
PROW/ADA:

Not Found, R304.2.2

Compliance	Description	Data	Compliance	Description	Data
N/A	Ramp Length (in)	47.5	No	Ramp Slope (%)	9.0
Yes	Ramp Width (in)	48.0	Yes	Ramp XSlope (%)	1.1
N/A	Flare Type LT	N/A	N/A	Flare Type RT	N/A
N/A	Flare Slope LT (%)	N/A	N/A	Flare Slope RT (%)	N/A
N/A	Flare Traversable LT?	N/A	N/A	Flare Traversable RT?	N/A
N/A	Landing Length (in)	N/A	N/A	DWS Provided?	N/A
N/A	Landing Width (in)	N/A	N/A	DWS Contrast?	N/A
N/A	Landing Slope (%)	N/A	N/A	DWS Length (in)	N/A
N/A	Landing X Slope (%)	N/A	N/A	DWS Full Width?	N/A
N/A	Landing Curb? (Y/N)	N/A	N/A	DWS Offset (in)	N/A
N/A	Shared Landing?	N/A			
N/A	Gutter Ponding?	N/A	N/A	Gutter Slope (%)	N/A
N/A	Gutter Lip Ht (in)	N/A	N/A	Gutter X Slope (%)	N/A
N/A	Painted X Walk1?	No	N/A	Painted X Walk2?	N/A
	X Walk 1 Direction	To NE		X Walk 2 Direction	N/A
N/A	X Walk 1 Width (in)	N/A	N/A	X Walk 2 Width (in)	N/A
	X Walk 1 Slope (%)	2.3		X Walk 2 Slope (%)	N/A
	X Walk 1 X Slope (%)	0.9		X Walk 2 X Slope (%)	N/A

Possible Solutions:

Remove & Replace Entire Ramp.

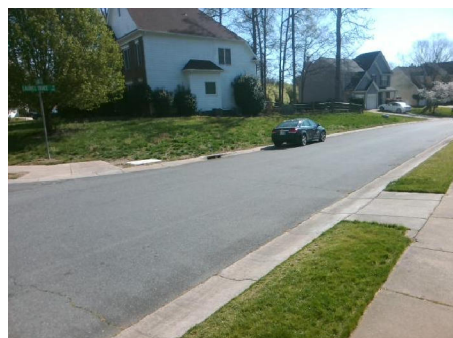
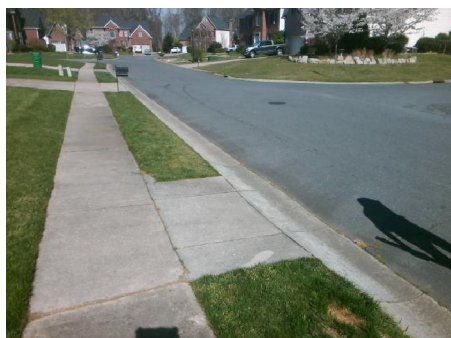
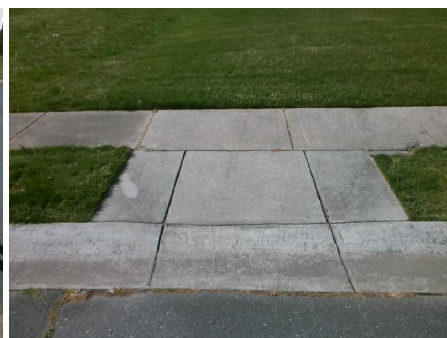
N/A	Ramp inside XWalk1?	N/A	N/A	Ramp inside XWalk2?	N/A
	Road Slope (%)	N/A	N/A	Clear Space?	N/A
	Road X Slope (%)	N/A	N/A	Clear Space to XWalk (in)	N/A
N/A	Any Obstructions?	N/A	N/A	Storm Grate/Utility Hazard?	N/A
	Obstruction Type			Storm Grate/Utility Type	
		N/A			N/A
			Yes	Surface Condition? (G/P)	Good
