# Access Compliance Report

## Public Rights-of-Way

### (Curb Ramps)

| Intersection ID: 9891 | Main Street: RAPHAEL_PL | Cross Street: CARD_ST | Location: | N |

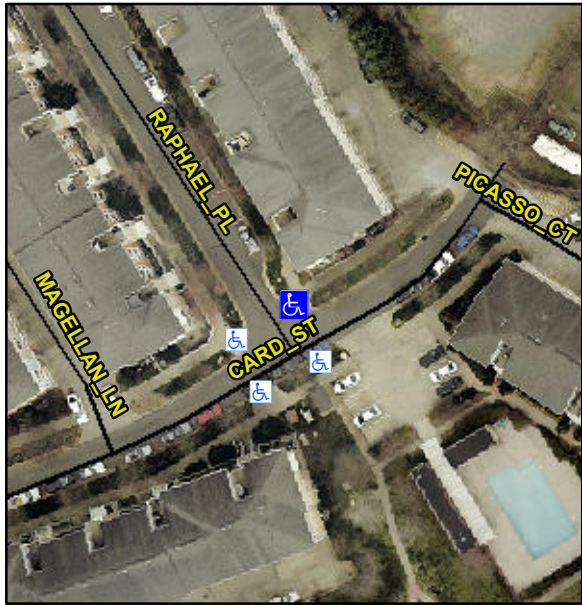
| ADA ID: 2238E3A3BF89 | Ramp Type: PerpDiag | Initial Pass/Fail: Pass | Overall Compliance: No | Severity Score: 2.75 |

| Codes/Mitigation Info/Possible Solution | | | Field Measurements/Component Compliance | | | | | |
|--|--|---|---|---|---|---|---|---|
| | | | Yes | Ramp Width (in) | 48.0 | No | Ramp XSlope (%) | 2.4 |
| | | | N/A | Flare Slope LT (%) | 5.5 | No | Flare Slope RT (%) | 10.5 |
| | | | No | Landing Length (in) | 39.0 | Yes | DWS Provided? | Yes |
| | | | No | Landing Slope (%) | 4.2 | Yes | DWS Length (in) | 25.5 |
| PROW/ADA: | | Not Found, R304.5.3, R304.2.1, R304.2.2-Perp, R304.3.2-Para, R304.2.3, R305.2 | N/A | Shared Landing? | No | | | |

| Codes/Mitigation Info/Possible Solution | | | Field Measurements/Component Compliance | | | | | |
|--|--|---|---|---|---|---|---|---|
| | Remove & Replace Curb Ramp With Two New Directional Ramps or Equivalent. | | N/A | Ramp Length (in) | 91.0 | Yes | Ramp Slope (%) | 8.0 |

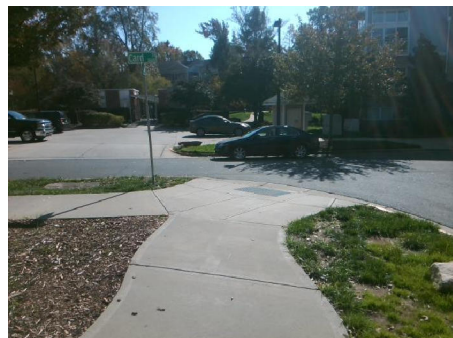
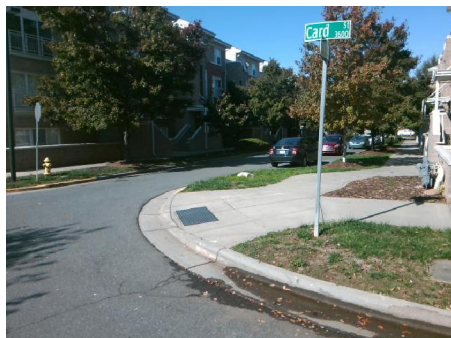
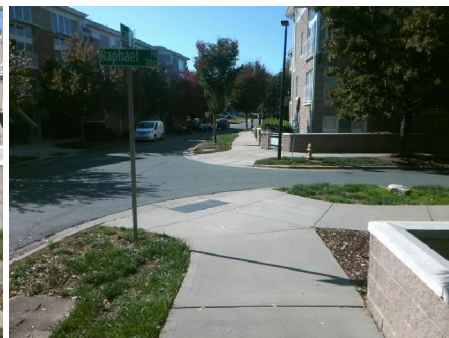
| Codes/Mitigation Info/Possible Solution | | | Field Measurements/Component Compliance | | | | | |
|--|--|---|---|---|---|---|---|---|
| Surveyor Notes: | | N/A | N/A | Landing Curb? (Y/N) | No | No | DWS Offset (in) | 5.0 |

Total Cost: \$ 3200.00
