# Access Compliance Report

## Public Rights-of-Way (Curb Ramps)

Intersection ID: 3539	Main Street: HARRIS_CORNERS_PY	Cross Street: MAPLE_VIEW_LN	Location: SW
ADA ID: 223A3AA9B78F	Ramp Type: Perp	Initial Pass/Fail: Fail	Overall Compliance: No
			Severity Score: 25

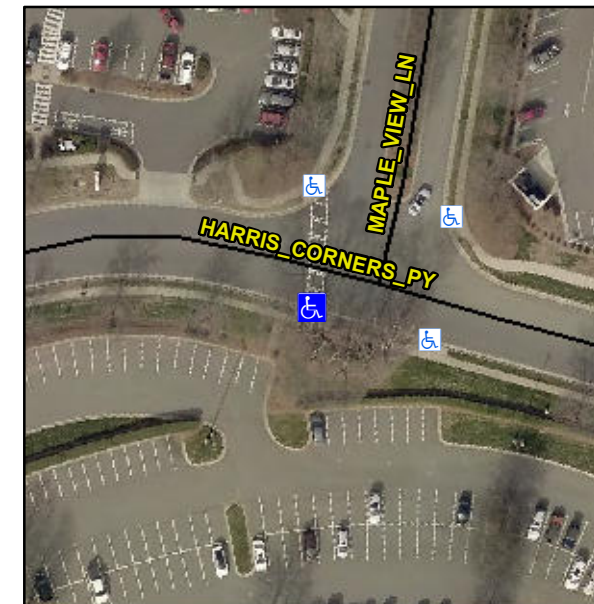
Compliance	Description	Data	Compliance	Description	Data
N/A	Ramp Length (in)	47.0	No	Ramp Slope (%)	14.9
Yes	Ramp Width (in)	50.0	Yes	Ramp XSlope (%)	0.1
N/A	Flare Type LT	N/A	N/A	Flare Type RT	N/A
N/A	Flare Slope LT (%)	N/A	N/A	Flare Slope RT (%)	N/A
N/A	Flare Traversable LT?	N/A	N/A	Flare Traversable RT?	N/A
N/A	Landing Length (in)	N/A	N/A	DWS Provided?	N/A
N/A	Landing Width (in)	N/A	N/A	DWS Contrast?	N/A
N/A	Landing Slope (%)	N/A	N/A	DWS Length (in)	N/A
N/A	Landing X Slope (%)	N/A	N/A	DWS Full Width?	N/A
N/A	Landing Curb? (Y/N)	N/A	N/A	DWS Offset (in)	N/A
N/A	Shared Landing?	N/A			
N/A	Gutter Ponding?	N/A	N/A	Gutter Slope (%)	N/A
N/A	Gutter Lip Ht (in)	N/A	N/A	Gutter X Slope (%)	N/A
N/A	Painted X Walk1?	Yes	N/A	Painted X Walk2?	N/A
	X Walk 1 Direction	To N		X Walk 2 Direction	N/A
N/A	X Walk 1 Width (in)	88.0	N/A	X Walk 2 Width (in)	N/A
	X Walk 1 Slope (%)	0.7		X Walk 2 Slope (%)	N/A
	X Walk 1 X Slope (%)	0.4		X Walk 2 X Slope (%)	N/A

N/A	Ramp inside XWalk1?	Yes	N/A	Ramp inside XWalk2?	N/A
	Road Slope (%)	N/A	N/A	Clear Space?	N/A
	Road X Slope (%)	N/A	N/A	Clear Space to XWalk (in)	N/A
N/A	Any Obstructions?	N/A	N/A	Storm Grate/Utility Hazard?	N/A
	Obstruction Type			Storm Grate/Utility Type	
		N/A			N/A
			Yes	Surface Condition? (G/P)	Good

**Remove & Replace Entire Ramp.**

**R304.2.2**

**\$ 1850.00**
