Access Compliance Report

Public Rights-of-Way

| Intersection ID: 26134 | Main Street: NUTHATCH_CT | Cross Street: SANDPIPER_DR | Location: | E |
| ADA ID: 223C59C3FFF1 | Ramp Type: BlendTrans2 | Initial Pass/Fail: Fail | Overall Compliance: No | Severity Score: 12.5 |

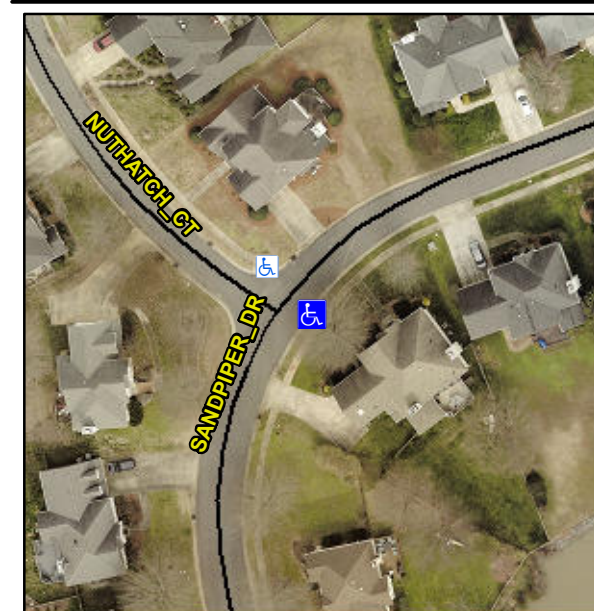
Not Found, R304.5.3

| Compliance | Description | Data | Compliance | Description | Data |
|---|---|---|---|---|---|
| Yes | Ramp Width (in) | 96.0 | No | BlendTrans XSlope (%) | 5.7 |
| | | | No | Curb Slope (%) | 11.5 |

Remove & Replace Curb Ramp With Two New Directional Ramps or Equivalent.
