Access Compliance Report

Public Rights-of-Way

(Curb Ramps)

Intersection ID: 19402	Main Street: GRETNA_GREEN_DR	Cross Street: S_TRYON_ST	Location: NE
ADA ID: 223D0DAC9553	Ramp Type: Perp	Initial Pass/Fail: Fail	Overall Compliance: No
Severity Score: 22.5			
Codes/Mitigation Info/Possible Solution		Field Measurements/Component Compliance

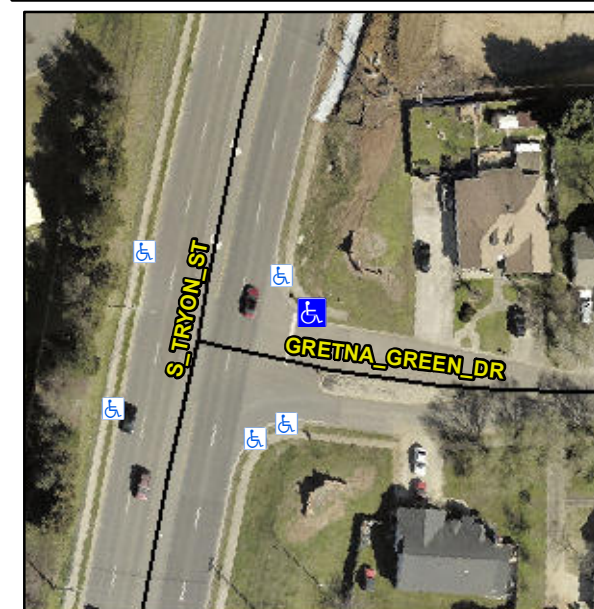
Not Found, R304.5.1, R304.2.2, R304.5.3

Compliance	Description	Data	Compliance	Description	Data
N/A	Ramp Length (in)	91.0	No	Ramp Slope (%)	9.6
No	Ramp Width (in)	45.0	No	Ramp XSlope (%)	2.4
N/A	Flare Type LT	N/A	N/A	Flare Type RT	N/A
N/A	Flare Slope LT (%)	N/A	N/A	Flare Slope RT (%)	N/A
N/A	Flare Traversable LT?	N/A	N/A	Flare Traversable RT?	N/A
N/A	Landing Length (in)	N/A	N/A	DWS Provided?	N/A
N/A	Landing Width (in)	N/A	N/A	DWS Contrast?	N/A
N/A	Landing Slope (%)	N/A	N/A	DWS Length (in)	N/A
N/A	Landing X Slope (%)	N/A	N/A	DWS Full Width?	N/A
N/A	Landing Curb? (Y/N)	N/A	N/A	DWS Offset (in)	N/A
N/A	Shared Landing?	N/A			
N/A	Gutter Ponding?	N/A	N/A	Gutter Slope (%)	N/A
N/A	Gutter Lip Ht (in)	N/A	N/A	Gutter X Slope (%)	N/A
N/A	Painted X Walk1?	No	N/A	Painted X Walk2?	N/A
	X Walk 1 Direction	To S		X Walk 2 Direction	N/A
N/A	X Walk 1 Width (in)	N/A	N/A	X Walk 2 Width (in)	N/A
	X Walk 1 Slope (%)	1.5		X Walk 2 Slope (%)	N/A
	X Walk 1 X Slope (%)	3.9		X Walk 2 X Slope (%)	N/A

Remove & Replace Entire Ramp.
