# Access Compliance Report

## Public Rights-of-Way (Curb Ramps)

| Intersection ID: 21431 | Main Street: WOODSTREAM_DR | Cross Street: WRENTREE_DR | Location: NW |
| ADA ID: 225F8B581916 | Ramp Type: Directional1 | Initial Pass/Fail: Fail | Overall Compliance: No |

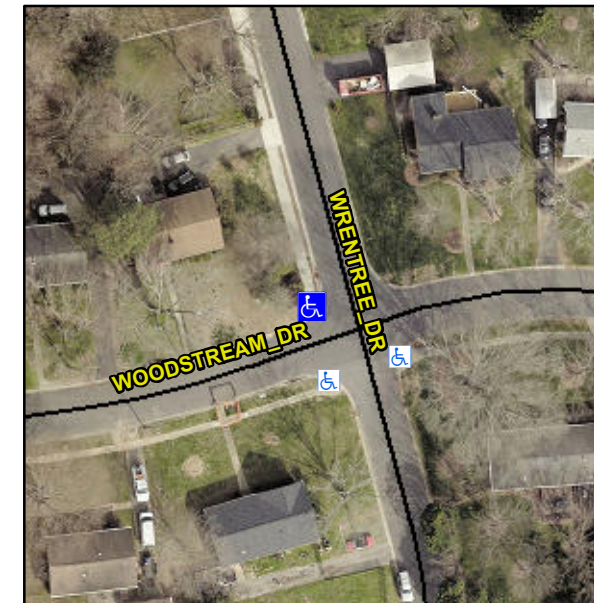
| | | Severity Score: 12.5 | |

PROW/ADA:

**R304.5.3**

| Compliance | Description | Data | Compliance | Description | Data |
|---|---|---|---|---|---|
| No | Ramp XSlope (%) | 5.2 | | | |

Possible Solutions:

**Remove & Replace Entire Ramp.**

Total Cost:

\$ 1600.00
