## Access Compliance Report Public Rights-of-Way (Curb Ramps)

Intersection ID: 9356 Main Street: E\_36TH\_ST Cross Street: N\_TRYON\_ST Location: SE

ADA ID: 2269BD1D3E59 Ramp Type: Perp Initial Pass/Fail: Fail Overall Compliance: No Severity Score: 33.75

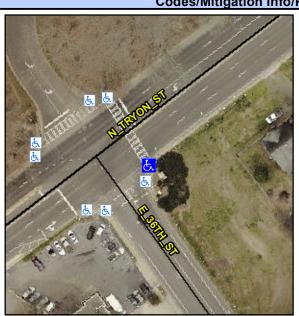
Not Found, R304.5.1, R304.5.3

Field Measurements/Component Compliance							
Compl	iance Description	Data	Comp	liance Description	Data		
N/A	Ramp Length (in)	62.5	Yes	Ramp Slope (%)	5.1		
No	Ramp Width (in)	38.5	No	Ramp XSlope (%)	8.1		
N/A	Flare Type LT	N/A	N/A	Flare Type RT	N/A		
N/A	Flare Slope LT (%)	N/A	N/A	Flare Slope RT (%)	N/A		
N/A	Flare Traversable LT?	N/A	N/A	Flare Traversable RT?	N/A		
N/A	Landing Length (in)	N/A	N/A	DWS Provided?	N/A		
N/A	Landing Width (in)	N/A	N/A	DWS Contrast?	N/A		
N/A	Landing Slope (%)	N/A	N/A	DWS Length (in)	N/A		
N/A	Landing X Slope (%)	N/A	N/A	DWS Full Width?	N/A		
N/A	Landing Curb? (Y/N)	N/A	N/A	DWS Offset (in)	N/A		
N/A	Shared Landing?	N/A					
N/A	Gutter Ponding?	N/A	N/A	Gutter Slope (%)	N/A		
N/A	Gutter Lip Ht (in)	N/A	N/A	Gutter X Slope (%)	N/A		
N/A	Painted X Walk1?	Yes	N/A	Painted X Walk2?	N/A		
	X Walk 1 Direction	To N		X Walk 2 Direction	N/A		
N/A	X Walk 1 Width (in)	100.0	N/A	X Walk 2 Width (in)	N/A

X Walk 1 Slope (%)	5.3		X Walk 2 Slope (%)	N/A		
	X Walk 1 X Slope (%)	5.0		X Walk 2 X Slope (%)	N/A		
N/A	Ramp inside XWalk1?	Yes	N/A	Ramp inside XWalk2?	N/A		
	Road Slope (%)	N/A	N/A	Clear Space?	N/A		
	Road X Slope (%)	N/A	N/A	Clear Space to XWalk (in)	N/A		
N/A	Any Obstructions?	N/A	N/A	Storm Grate/Utility Hazard?	N/A		
	Obstruction Type			Storm Grate/Utility Type			
		N/A			N/A		
			Yes	Surface Condition? (G/P)	Good

Remove & Replace Entire Ramp.
