Access Compliance Report

Public Rights-of-Way

(Curb Ramps)

Intersection ID: 42734	Main Street: GRIER_SPRINGS_LN	Cross Street: CALDWELL_FOREST_DR	Location: E
ADA ID: 226B7D245B87	Ramp Type: PerpDiag	Initial Pass/Fail: Fail	Overall Compliance: No
Severity Score: 17.5			
Codes/Mitigation Info/Possible Solution		Field Measurements/Component Compliance

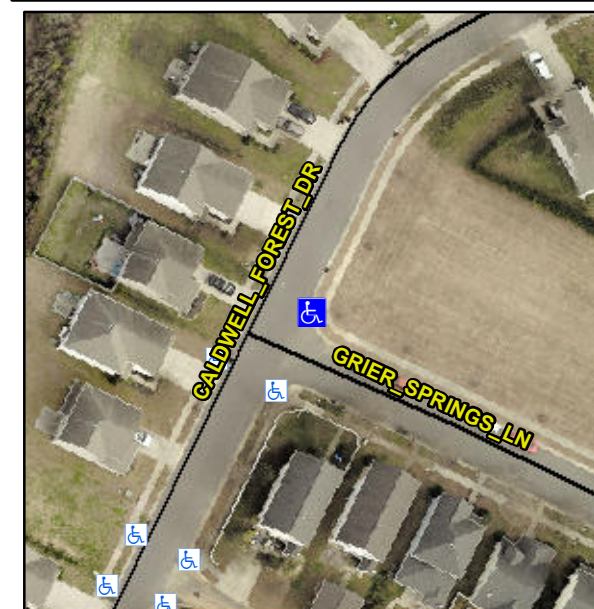
Compliance	Description	Data	Compliance	Description	Data
N/A	Ramp Length (in)	51.0	Yes	Ramp Slope (%)	6.1
No	Ramp Width (in)	32.0	Yes	Ramp XSlope (%)	0.3
N/A	Flare Type LT	N/A	N/A	Flare Type RT	N/A
N/A	Flare Slope LT (%)	N/A	N/A	Flare Slope RT (%)	N/A
N/A	Flare Traversable LT?	N/A	N/A	Flare Traversable RT?	N/A
N/A	Landing Length (in)	N/A	N/A	DWS Provided?	N/A
N/A	Landing Width (in)	N/A	N/A	DWS Contrast?	N/A
N/A	Landing Slope (%)	N/A	N/A	DWS Length (in)	N/A
N/A	Landing X Slope (%)	N/A	N/A	DWS Full Width?	N/A
N/A	Landing Curb? (Y/N)	N/A	N/A	DWS Offset (in)	N/A
N/A	Shared Landing?	N/A			
N/A	Gutter Ponding?	N/A	N/A	Gutter Slope (%)	N/A
N/A	Gutter Lip Ht (in)	N/A	N/A	Gutter X Slope (%)	N/A
N/A	Painted X Walk1?	No	N/A	Painted X Walk2?	No
	X Walk 1 Direction	To W		X Walk 2 Direction	To S
N/A	X Walk 1 Width (in)	N/A	N/A	X Walk 2 Width (in)	N/A
	X Walk 1 Slope (%)	3.3		X Walk 2 Slope (%)	3.5
	X Walk 1 X Slope (%)	4.6		X Walk 2 X Slope (%)	2.7

N/A	Ramp inside XWalk1?	N/A	N/A	Ramp inside XWalk2?	N/A
	Road Slope (%)	2.4	N/A	Clear Space?	N/A
	Road X Slope (%)	4.5	N/A	Clear Space to XWalk (in)	N/A
N/A	Any Obstructions?	N/A	N/A	Storm Grate/Utility Hazard?	N/A
	Obstruction Type			Storm Grate/Utility Type	
		N/A			N/A
		Yes		Surface Condition? (G/P)	Good

Remove & Replace Curb Ramp With Two New Directional Ramps or Equivalent.

Not Found, R304.5.1
