Access Compliance Report Public Rights-of-Way (Curb Ramps)

Intersection ID: 10023890Main Street: COMMUNITY_HOUSE_RDCross Street: N/ALocation:NWADA ID: 226BD95BCB58Ramp Type: PerpInitial Pass/Fail: FailOverall Compliance: NoSeverity Score:25

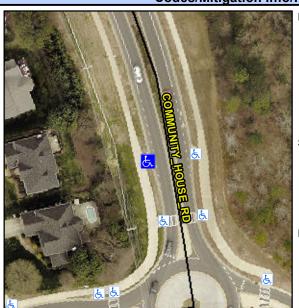
Comp	liance Description	Data		liance Description	Data
N/A	Ramp Length (in)	71.0	No	Ramp Slope (%)	14.2
Yes	Ramp Width (in)	111.0	Yes	Ramp XSlope (%)	1.1
N/A	Flare Type LT	N/A	N/A	Flare Type RT	N/A
N/A	Flare Slope LT (%)	N/A	N/A	Flare Slope RT (%)	N/A
N/A	Flare Traversable LT?	N/A	N/A	Flare Traversable RT?	N/A
N/A	Landing Length (in)	N/A	N/A	DWS Provided?	N/A
N/A	Landing Width (in)	N/A	N/A	DWS Contrast?	N/A
N/A	Landing Slope (%)	N/A	N/A	DWS Length (in)	N/A
N/A	Landing X Slope (%)	N/A	N/A	DWS Full Width?	N/A
N/A	Landing Curb? (Y/N)	N/A	N/A	DWS Offset (in)	N/A
N/A	Shared Landing?	N/A			
N/A	Gutter Ponding?	N/A	N/A	Gutter Slope (%)	N/A
N/A	Gutter Lip Ht (in)	N/A	N/A	Gutter X Slope (%)	N/A
N/A	Painted X Walk1?	No	N/A	Painted X Walk2?	N/A
	X Walk 1 Direction	To E		X Walk 2 Direction	N/A
N/A	X Walk 1 Width (in)	N/A	N/A	X Walk 2 Width (in)	N/A
	X Walk 1 Slope (%)	4.3		X Walk 2 Slope (%)	N/A
	X Walk 1 X Slope (%)	1.8		X Walk 2 X Slope (%)	N/A

N/A	Ramp inside XWalk1?	N/A	N/A	Ramp inside XWalk2?	N/A
	Road Slope (%)	N/A	N/A	Clear Space?	N/A
	Road X Slope (%)	N/A	N/A	Clear Space to XWalk (in)	N/A
N/A	Any Obstructions?	N/A	N/A	Storm Grate/Utility Hazard?	N/A
	Obstruction Type			Storm Grate/Utility Type	
		N/A			N/A
			Yes	Surface Condition? (G/P)	Good

Possible Solutions:						
Remove & Replace Entire Ramp.						
Surveyor Notes:						
N/A						
PROW/ADA:						
R304.2.2
