Access Compliance Report

Public Rights-of-Way

(Curb Ramps)

Intersection ID: 10721	Main Street: HERRIN_AV	Cross Street: TAPPAN_PL	Location: N
ADA ID: 226E91458F05	Ramp Type: PerpDiag	Initial Pass/Fail: Fail	Overall Compliance: No
			Severity Score: 13.75

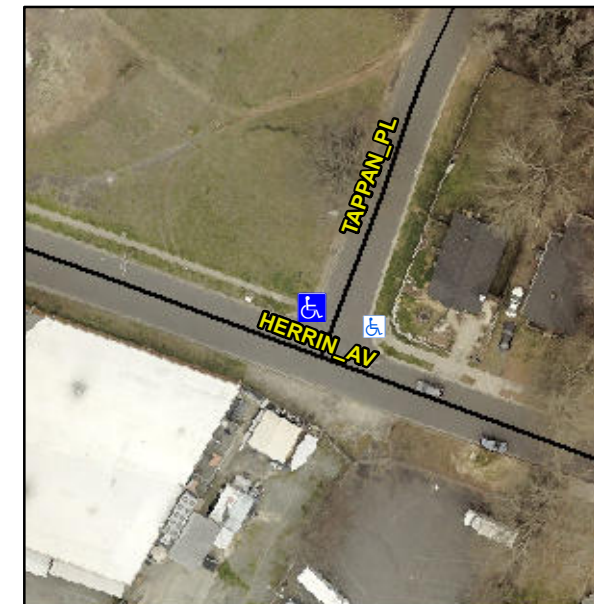
Not Found, R304.2.2, R304.5.3

Compliance	Description	Data	Compliance	Description	Data
N/A	Ramp Length (in)	48.5	No	Ramp Slope (%)	9.0
Yes	Ramp Width (in)	48.0	No	Ramp XSlope (%)	4.4
N/A	Flare Type LT	N/A	N/A	Flare Type RT	N/A
N/A	Flare Slope LT (%)	N/A	N/A	Flare Slope RT (%)	N/A
N/A	Flare Traversable LT?	N/A	N/A	Flare Traversable RT?	N/A
N/A	Landing Length (in)	N/A	N/A	DWS Provided?	N/A
N/A	Landing Width (in)	N/A	N/A	DWS Contrast?	N/A
N/A	Landing Slope (%)	N/A	N/A	DWS Length (in)	N/A
N/A	Landing X Slope (%)	N/A	N/A	DWS Full Width?	N/A
N/A	Landing Curb? (Y/N)	N/A	N/A	DWS Offset (in)	N/A
N/A	Shared Landing?	N/A			
N/A	Gutter Ponding?	N/A	N/A	Gutter Slope (%)	N/A
N/A	Gutter Lip Ht (in)	N/A	N/A	Gutter X Slope (%)	N/A
N/A	Painted X Walk1?	No	N/A	Painted X Walk2?	No
	X Walk 1 Direction	To SW		X Walk 2 Direction	To SE
N/A	X Walk 1 Width (in)	N/A	N/A	X Walk 2 Width (in)	N/A
	X Walk 1 Slope (%)	3.2		X Walk 2 Slope (%)	2.3
	X Walk 1 X Slope (%)	0.5		X Walk 2 X Slope (%)	3.4

N/A	Ramp inside XWalk1?	N/A	N/A	Ramp inside XWalk2?	N/A
	Road Slope (%)	4.2	N/A	Clear Space?	N/A
	Road X Slope (%)	2.9	N/A	Clear Space to XWalk (in)	N/A
N/A	Any Obstructions?	N/A	N/A	Storm Grate/Utility Hazard?	N/A
	Obstruction Type			Storm Grate/Utility Type	
		N/A			N/A
			Yes	Surface Condition? (G/P)	Good

Remove & Replace Curb Ramp With Two New Directional Ramps or Equivalent.
