Access Compliance Report

Public Rights-of-Way

(Curb Ramps)

Intersection ID: 47912	Main Street: MOUNTAIN_QUAIL_DR	Cross Street: MEARN_RD	Location: W
ADA ID: 2288E8DD986E	Ramp Type: PerpDiag	Initial Pass/Fail: Fail	Overall Compliance: No
Severity Score: 17.5			
Codes/Mitigation Info/Possible Solution		Field Measurements/Component Compliance

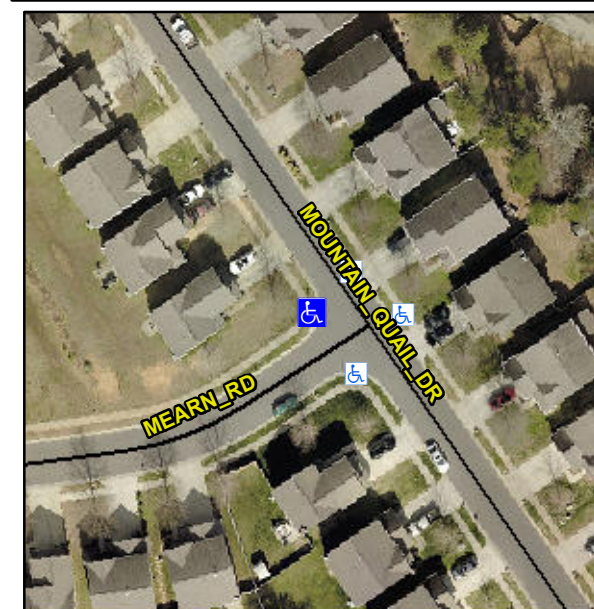
Compliance	Description	Data	Compliance	Description	Data
N/A	Ramp Length (in)	48.0	Yes	Ramp Slope (%)	5.3
No	Ramp Width (in)	33.5	Yes	Ramp XSlope (%)	1.2
N/A	Flare Type LT	N/A	N/A	Flare Type RT	N/A
N/A	Flare Slope LT (%)	N/A	N/A	Flare Slope RT (%)	N/A
N/A	Flare Traversable LT?	N/A	N/A	Flare Traversable RT?	N/A
N/A	Landing Length (in)	N/A	N/A	DWS Provided?	N/A
N/A	Landing Width (in)	N/A	N/A	DWS Contrast?	N/A
N/A	Landing Slope (%)	N/A	N/A	DWS Length (in)	N/A
N/A	Landing X Slope (%)	N/A	N/A	DWS Full Width?	N/A
N/A	Landing Curb? (Y/N)	N/A	N/A	DWS Offset (in)	N/A
N/A	Shared Landing?	N/A			
N/A	Gutter Ponding?	N/A	N/A	Gutter Slope (%)	N/A
N/A	Gutter Lip Ht (in)	N/A	N/A	Gutter X Slope (%)	N/A
N/A	Painted X Walk1?	No	N/A	Painted X Walk2?	No
	X Walk 1 Direction	To SE		X Walk 2 Direction	To E
N/A	X Walk 1 Width (in)	N/A	N/A	X Walk 2 Width (in)	N/A
	X Walk 1 Slope (%)	0.3		X Walk 2 Slope (%)	10.1
	X Walk 1 X Slope (%)	2.3		X Walk 2 X Slope (%)	0.3

N/A	Ramp inside XWalk1?	N/A	N/A	Ramp inside XWalk2?	N/A
	Road Slope (%)	0.3	N/A	Clear Space?	N/A
	Road X Slope (%)	4.0	N/A	Clear Space to XWalk (in)	N/A
N/A	Any Obstructions?	N/A	N/A	Storm Grate/Utility Hazard?	N/A
	Obstruction Type			Storm Grate/Utility Type	
		N/A			N/A
		Yes		Surface Condition? (G/P)	Good

Possible Solutions:

Remove & Replace Curb Ramp With Two New Directional Ramps or Equivalent.

Not Found, R304.5.1

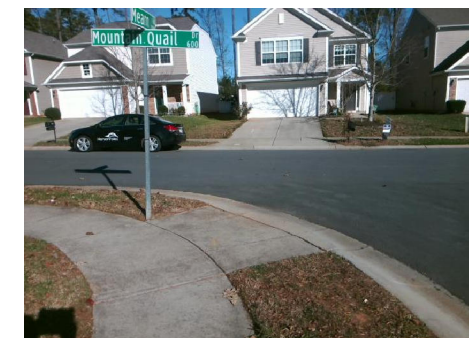
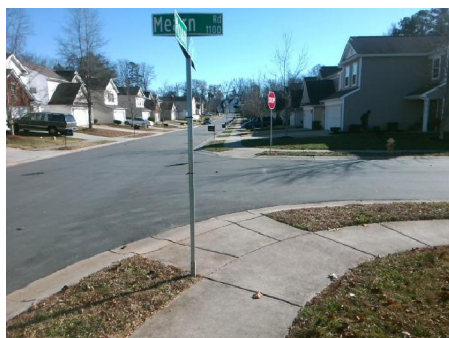
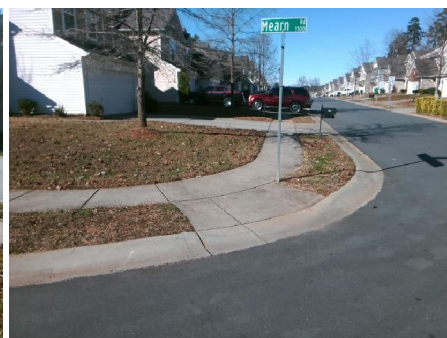
Street 1 Name MEARN RD
 Stop Condition-Street 2 StopSign
 Street 2 Name MOUNTAIN QUAIL DR
 Stop Condition-Street 1 None
