Access Compliance Report

Public Rights-of-Way

(Curb Ramps)

Intersection ID: 48088	Main Street: MALLARD_HIGHLANDS_DR	Cross Street: JOHN_ADAMS_RD	Location:	S
ADA ID: 229B5D191691	Ramp Type: BlendTrans1	Initial Pass/Fail: Fail	Overall Compliance: No	Severity Score: 10

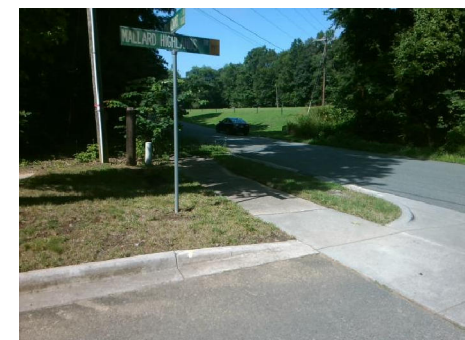
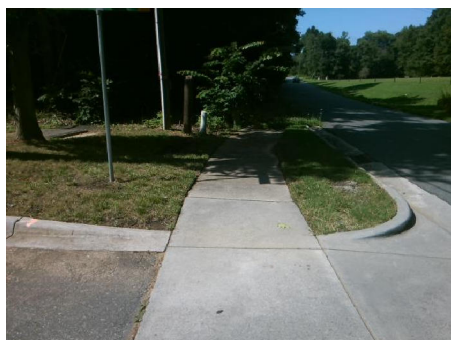
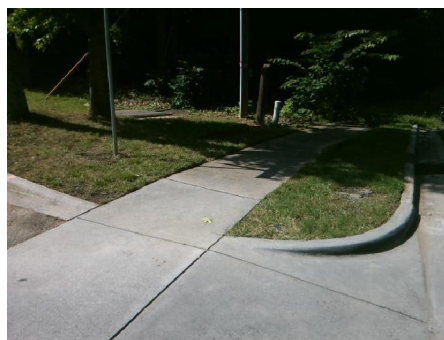
Compliance	Description	Data	Compliance	Description	Data
N/A	Ramp Length (in)	58.0	Yes	BlendTrans Slope (%)	0.1
No	Ramp Width (in)	47.0	No	BlendTrans XSlope (%)	4.1
N/A	Flare Type LT	N/A	N/A	Flare Type RT	N/A
N/A	Flare Slope LT (%)	N/A	N/A	Flare Slope RT (%)	N/A
N/A	Flare Traversable LT?	N/A	N/A	Flare Traversable RT?	N/A
N/A	Landing Length (in)	N/A	N/A	DWS Provided?	N/A
N/A	Landing Width (in)	N/A	N/A	DWS Contrast?	N/A
N/A	Landing Slope (%)	N/A	N/A	DWS Length (in)	N/A
N/A	Landing X Slope (%)	N/A	N/A	DWS Full Width?	N/A
N/A	Landing Curb? (Y/N)	N/A	N/A	DWS Offset (in)	N/A
N/A	Shared Landing?	N/A			
N/A	Gutter Ponding?	N/A	N/A	Gutter Slope (%)	N/A
N/A	Gutter Lip Ht (in)	N/A	N/A	Gutter X Slope (%)	N/A
N/A	Painted X Walk1?	No	N/A	Painted X Walk2?	N/A
	X Walk 1 Direction	To NE		X Walk 2 Direction	N/A
	X Walk 1 Width (in)	N/A		X Walk 2 Width (in)	N/A
	X Walk 1 Slope (%)	0.7		X Walk 2 Slope (%)	N/A
	X Walk 1 X Slope (%)	1.9		X Walk 2 X Slope (%)	N/A

N/A	Ramp inside XWalk1?	N/A	N/A	Ramp inside XWalk2?	N/A
	Road Slope (%)	1.9		Clear Space?	N/A
	Road X Slope (%)	0.7	N/A	Clear Space to XWalk (in)	N/A
N/A	Any Obstructions?	N/A	N/A	Storm Grate/Utility Hazard?	N/A
	Obstruction Type			Storm Grate/Utility Type	
		N/A			N/A
			Yes	Surface Condition? (G/P)	Good
			N/A	Curb Slope (%)	N/A

Possible Solutions:

Remove & Replace Curb Ramp With Two New Directional Ramps or Equivalent.
