# Access Compliance Report

## Public Rights-of-Way

### (Curb Ramps)

| Intersection ID: N/A | Main Street: SHASTA_LN | Cross Street: SUNBURY_LN | Location: E |

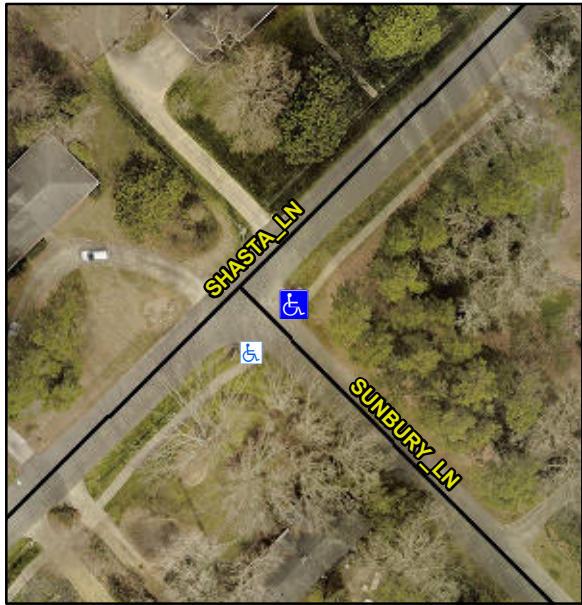
| ADA ID: 229E49134853 | Ramp Type: Directional1 | Initial Pass/Fail: Fail | Overall Compliance: No |

| Codes/Mitigation Info/Possible Solution | | | Field Measurements/Component Compliance | | | | | |
|--|---|---|---|---|---|---|---|---|
| | | | No | Ramp XSlope (%) | 3.7 | | | |
| R304.5.3 | | | N/A | Shared Landing? | N/A | N/A | DWS Offset RT (in) | N/A |

| Codes/Mitigation Info/Possible Solution | | | Field Measurements/Component Compliance | | | | | |
|--|---|---|---|---|---|---|---|---|
| | Remove & Replace Entire Ramp. | | N/A | Ramp Length (in) | 61.0 | N/A | Grade Break? | N/A |
