Access Compliance Report

Public Rights-of-Way

(Curb Ramps)

Intersection ID: 27948	Main Street: COUNTY_DONEGAL_CT	Cross Street: PINE_VALLEY_CLUB_DR	Location: SW
ADA ID: 229E7413B4F3	Ramp Type: Perp	Initial Pass/Fail: Pass	Overall Compliance: No
Severity Score: 10			
Codes/Mitigation Info/Possible Solution		Field Measurements/Component Compliance

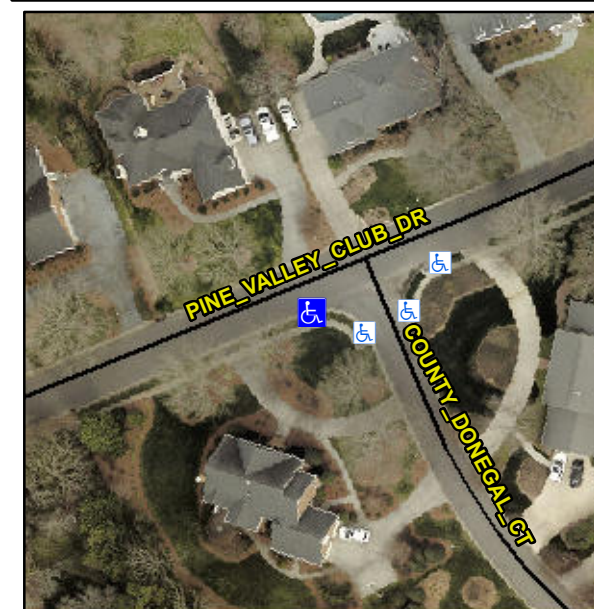
Not Found, R304.2.1, R304.2.2-Perp, R304.3.2-Para, R304.5.3, R305.2

Compliance	Description	Data	Compliance	Description	Data
N/A	Ramp Length (in)	94.0	Yes	Ramp Slope (%)	7.7
Yes	Ramp Width (in)	48.0	Yes	Ramp XSlope (%)	1.6
N/A	Flare Type LT	Sloped	N/A	Flare Type RT	N/A
N/A	Flare Slope LT (%)	5.6	Yes	Flare Slope RT (%)	1.9
N/A	Flare Traversable LT?	Yes	N/A	Flare Traversable RT?	Yes
No	Landing Length (in)	N/A	Yes	DWS Provided?	Yes
No	Landing Width (in)	N/A	Yes	DWS Contrast?	Yes
No	Landing Slope (%)	N/A	Yes	DWS Length (in)	24.0
No	Landing X Slope (%)	N/A	Yes	DWS Full Width?	Yes
N/A	Landing Curb? (Y/N)	No	No	DWS Offset (in)	3.0
N/A	Shared Landing?	No			
Yes	Gutter Ponding?	No	Yes	Gutter Slope (%)	2.2
Yes	Gutter Lip Ht (in)	0.0	Yes	Gutter X Slope (%)	1.9
N/A	Painted X Walk1?	No	N/A	Painted X Walk2?	N/A
	X Walk 1 Direction	To NW		X Walk 2 Direction	N/A
N/A	X Walk 1 Width (in)	N/A	N/A	X Walk 2 Width (in)	N/A
	X Walk 1 Slope (%)	3.5		X Walk 2 Slope (%)	N/A
	X Walk 1 X Slope (%)	1.1		X Walk 2 X Slope (%)	N/A

N/A	Ramp inside XWalk1?	N/A	N/A	Ramp inside XWalk2?	N/A
	Road Slope (%)	N/A	N/A	Clear Space?	Yes
	Road X Slope (%)	N/A	N/A	Clear Space to XWalk (in)	N/A
Yes	Any Obstructions?	No	Yes	Storm Grate/Utility Hazard?	No
	Obstruction Type			Storm Grate/Utility Type	
		N/A			N/A
			Yes	Surface Condition? (G/P)	Good

Possible Solutions:

Remove & Replace Entire Ramp.
