# Access Compliance Report

## Public Rights-of-Way

| Intersection ID: 27478 | Main Street: BALLANTYNE_MEADOWS_DR | Cross Street: BLUE_CEDAR_LN | Location: SE |
| ADA ID: 22A30E1C1EDA | Ramp Type: PerpDiag | Initial Pass/Fail: Fail | Overall Compliance: No |

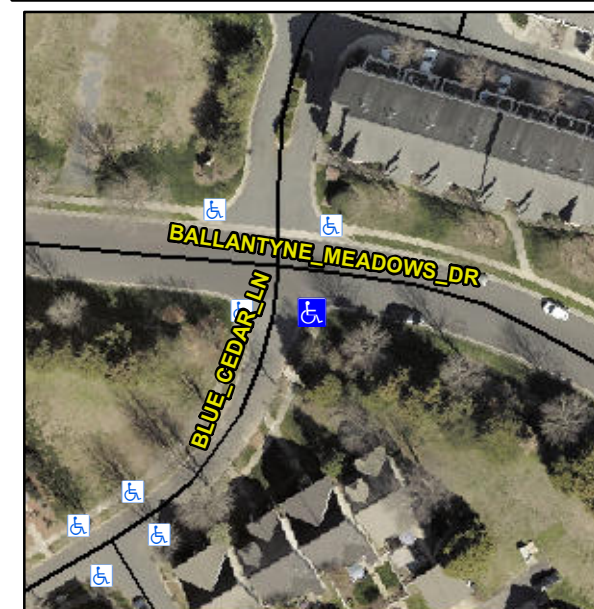
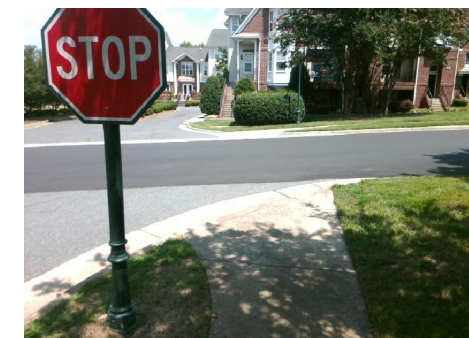
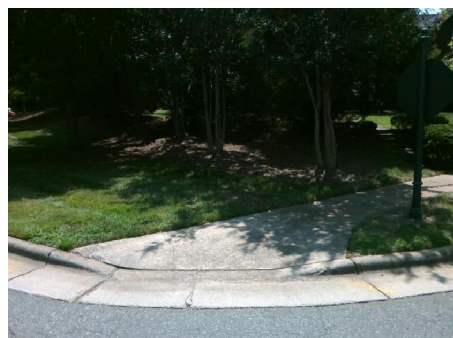
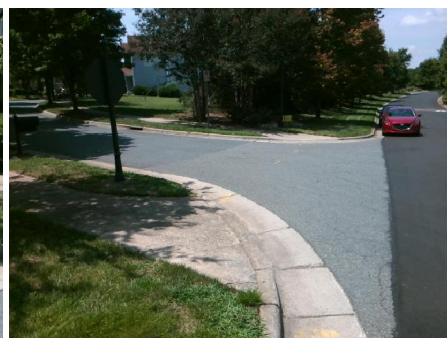
| Severity Score: 12.5 | | | |

| Compliance | Description | Data | Compliance | Description | Data |
|---|---|---|---|---|---|
| Yes | Ramp Width (in) | 48.0 | No | Ramp XSlope (%) | 5.1 |

**Remove & Replace Curb Ramp With Two New Directional Ramps or Equivalent.**

**R304.5.3**
