Access Compliance Report

Public Rights-of-Way

(Curb Ramps)

Intersection ID: 13769	Main Street: E_3RD_ST	Cross Street: CHERRY_ST	Location: SW
ADA ID: 22B3490C83C0	Ramp Type: PerpDiag	Initial Pass/Fail: Fail	Overall Compliance: No
		Severity Score: 12.5

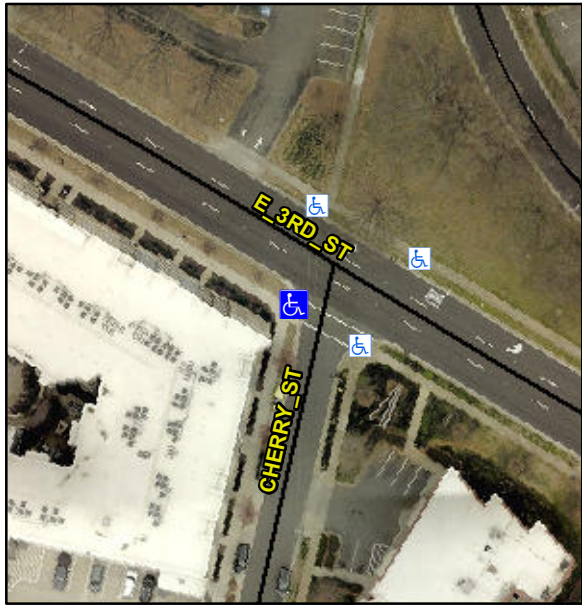
Possible Solutions:						
	Remove & Replace Curb Ramp With Two New Directional Ramps or Equivalent.						
	Surveyor Notes:						
	N/A						
	PROW/ADA:						
	Not Found, R304.2.2						
		Compliance	Description	Data	Compliance	Description	Data
		Description	Data	Description	Data		
		N/A	Ramp Length (in)	80.0	No	Ramp Slope (%)	8.6
		Yes	Ramp Width (in)	48.0	Yes	Ramp XSlope (%)	0.2
	N/A	Flare Type LT	N/A	N/A	Flare Type RT	N/A	
	N/A	Flare Slope LT (%)	N/A	N/A	Flare Slope RT (%)	N/A	
	N/A	Flare Traversable LT?	N/A	N/A	Flare Traversable RT?	N/A	
	N/A	Landing Length (in)	N/A	N/A	DWS Provided?	N/A	
	N/A	Landing Width (in)	N/A	N/A	DWS Contrast?	N/A	
	N/A	Landing Slope (%)	N/A	N/A	DWS Length (in)	N/A	
	N/A	Landing X Slope (%)	N/A	N/A	DWS Full Width?	N/A	
	N/A	Landing Curb? (Y/N)	N/A	N/A	DWS Offset (in)	N/A	
	N/A	Shared Landing?	N/A

N/A	Gutter Ponding?	N/A	N/A	Gutter Slope (%)	N/A	
	N/A	Gutter Lip Ht (in)	N/A	N/A	Gutter X Slope (%)	N/A	
	N/A	Painted X Walk1?	Yes	N/A	Painted X Walk2?	No	
		X Walk 1 Direction	To SE		X Walk 2 Direction	To NE	
	N/A	X Walk 1 Width (in)	111.5	N/A	X Walk 2 Width (in)	N/A	
		X Walk 1 Slope (%)	4.2		X Walk 2 Slope (%)	3.9	
		X Walk 1 X Slope (%)	1.4		X Walk 2 X Slope (%)	2.2	
	N/A	Ramp inside XWalk1?	Yes	N/A	Ramp inside XWalk2?	N/A	
		Road Slope (%)	0.2	N/A	Clear Space?	N/A	
		Road X Slope (%)	4.0	N/A	Clear Space to XWalk (in)	N/A	
	N/A	Any Obstructions?	N/A	N/A	Storm Grate/Utility Hazard?	N/A	
		Obstruction Type			Storm Grate/Utility Type		
			N/A			N/A	
				Yes	Surface Condition? (G/P)	Good	
Total Cost:		\$	3200.00
