## **Access Compliance Report Public Rights-of-Way** (Curb Ramps)

Intersection ID: 52288 Main Street: STEELE CREEK RD **Cross Street: DIXIE RIVER RD** Location: Ε

ADA ID: 22B3ABFFCD32 Ramp Type: PerpDiag Initial Pass/Fail: Fail **Overall Compliance: No Severity Score:** 8.75

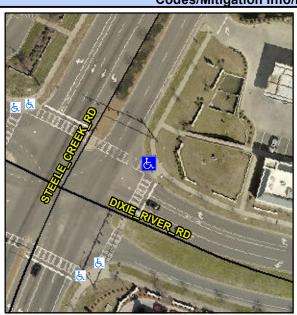
Field Measurements/Component Compliance							
	Compliance Description		Data	Compliance Description		Description	Data
	N/A	Ramp Length (in)	96.0	Yes	Ramp	Slope (%)	5.3
	No	Ramp Width (in)	47.0	Yes	Ramp	XSlope (%)	1.5
	N/A	Flare Type LT	N/A	N/A	Flare	Type RT	N/A
	N/A	Flare Slope LT (%)	N/A	N/A	Flare	Slope RT (%)	N/A
	N/A	Flare Traversable LT?	N/A	N/A	Flare	Traversable RT?	N/A
	N/A	Landing Length (in)	N/A	N/A	DWS	Provided?	N/A
	N/A	Landing Width (in)	N/A	N/A	DWS	Contrast?	N/A
	N/A	Landing Slope (%)	N/A	N/A	DWS	Length (in)	N/A
	N/A	Landing X Slope (%)	N/A	N/A	DWS	Full Width?	N/A
	N/A	Landing Curb? (Y/N)	N/A	N/A	DWS	Offset (in)	N/A
	N/A	Shared Landing?	N/A				
	N/A	Gutter Ponding?	N/A	N/A	Gutte	r Slope (%)	N/A
	N/A	Gutter Lip Ht (in)	N/A	N/A	Gutte	r X Slope (%)	N/A
	N/A	Painted X Walk1?	Yes	N/A	Paint	ed X Walk2?	Yes
		X Walk 1 Direction	To SW		X Wa	lk 2 Direction	To NW
	N/A	X Walk 1 Width (in)	108.0	N/A	X Wa	lk 2 Width (in)	111.0

X Walk 1 Slope (%)	2.5		X Wa	lk 2 Slope (%)	0.5
		X Walk 1 X Slope (%)	0.3		X Wa	lk 2 X Slope (%)	3.0
	N/A	Ramp inside XWalk1?	Yes	N/A	Ramp	inside XWalk2?	Yes
		Road Slope (%)	2.7	N/A	Clear	Space?	N/A
		Road X Slope (%)	2.3	N/A	Clear	Space to XWalk (in)	N/A
	N/A	Any Obstructions?	N/A	N/A	Storm	n Grate/Utility Hazard?	N/A
		Obstruction Type			Storm	n Grate/Utility Type	
			N/A				N/A
				Yes	Surfa	ce Condition? (G/P)	Good

**DIXIE RIVER RD** Street 1 Name Stop Condition-Street 2 Signal Street 2 Name STEELE CREEK RD Stop Condition-Street 1 Signal Possible Solutions: Remove & Replace Curb Ramp With **Two New Directional Ramps or** Equivalent. Surveyor Notes: N/A PROW/ADA: R304.5.1
