# Access Compliance Report

## Public Rights-of-Way

### (Curb Ramps)

Intersection ID: 10020374	Main Street: BALLANTYNE_CORPORATE_PL	Cross Street: N/A	Location: SW
ADA ID: 22B3C5582A1B	Ramp Type: Perp	Initial Pass/Fail: Fail	Overall Compliance: No
		Severity Score: 12.5	
Codes/Mitigation Info/Possible Solution		Field Measurements/Component Compliance

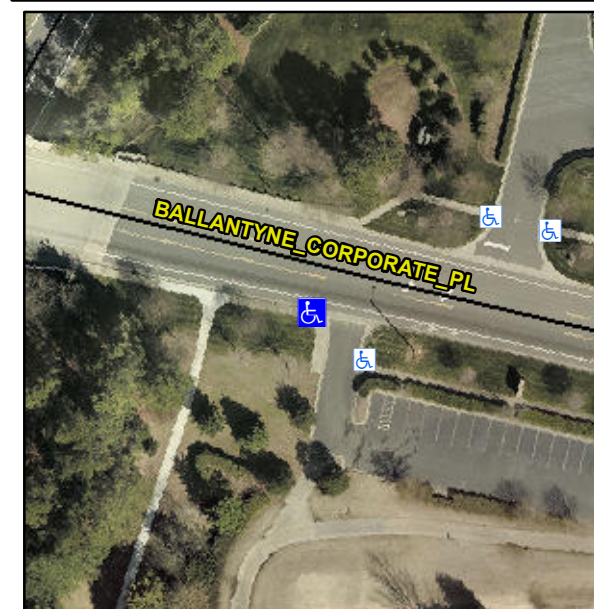
Compliance	Description	Data	Compliance	Description	Data
N/A	Ramp Length (in)	59.0	No	Ramp Slope (%)	8.6
Yes	Ramp Width (in)	48.0	Yes	Ramp XSlope (%)	1.5
N/A	Flare Type LT	N/A	N/A	Flare Type RT	N/A
N/A	Flare Slope LT (%)	N/A	N/A	Flare Slope RT (%)	N/A
N/A	Flare Traversable LT?	N/A	N/A	Flare Traversable RT?	N/A
N/A	Landing Length (in)	N/A	N/A	DWS Provided?	N/A
N/A	Landing Width (in)	N/A	N/A	DWS Contrast?	N/A
N/A	Landing Slope (%)	N/A	N/A	DWS Length (in)	N/A
N/A	Landing X Slope (%)	N/A	N/A	DWS Full Width?	N/A
N/A	Landing Curb? (Y/N)	N/A	N/A	DWS Offset (in)	N/A
N/A	Shared Landing?	N/A			
N/A	Gutter Ponding?	N/A	N/A	Gutter Slope (%)	N/A
N/A	Gutter Lip Ht (in)	N/A	N/A	Gutter X Slope (%)	N/A
N/A	Painted X Walk1?	No	N/A	Painted X Walk2?	N/A
	X Walk 1 Direction	To SE		X Walk 2 Direction	N/A
N/A	X Walk 1 Width (in)	N/A	N/A	X Walk 2 Width (in)	N/A
	X Walk 1 Slope (%)	0.8		X Walk 2 Slope (%)	N/A
	X Walk 1 X Slope (%)	1.9		X Walk 2 X Slope (%)	N/A

**Remove & Replace Entire Ramp.**

**R304.2.2**
