Access Compliance Report

Public Rights-of-Way

(Curb Ramps)

Intersection ID: 21038	Main Street: BROCKTON_LN	Cross Street: PROVIDENCE_RD	Location: NW
ADA ID: 22D095F488DD	Ramp Type: PerpDiag	Initial Pass/Fail: Fail	Overall Compliance: No
			Severity Score: 21.25

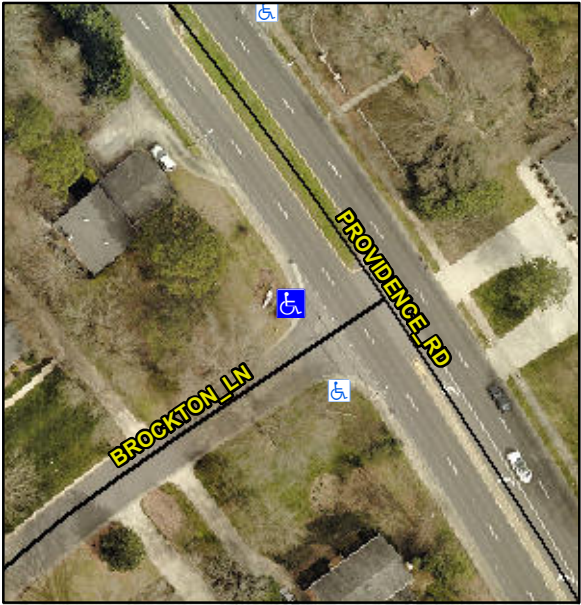
Possible Solutions:						
	Remove & Replace Curb Ramp With Two New Directional Ramps or Equivalent.						
	Surveyor Notes:						
	N/A						
	PROW/ADA:						
	R304.5.1, R304.5.3						
		Compliance	Description	Data	Compliance	Description	Data
		N/A	Ramp Length (in)	59.0	Yes	Ramp Slope (%)	7.1
		No	Ramp Width (in)	37.0	No	Ramp XSlope (%)	6.5
		N/A	Flare Type LT	N/A	N/A	Flare Type RT	N/A
		N/A	Flare Slope LT (%)	N/A	N/A	Flare Slope RT (%)	N/A
		N/A	Flare Traversable LT?	N/A	N/A	Flare Traversable RT?	N/A
		N/A	Landing Length (in)	N/A	N/A	DWS Provided?	N/A
		N/A	Landing Width (in)	N/A	N/A	DWS Contrast?	N/A
		N/A	Landing Slope (%)	N/A	N/A	DWS Length (in)	N/A
		N/A	Landing X Slope (%)	N/A	N/A	DWS Full Width?	N/A
		N/A	Landing Curb? (Y/N)	N/A	N/A	DWS Offset (in)	N/A
		N/A	Shared Landing?	N/A			
		N/A	Gutter Ponding?	N/A	N/A	Gutter Slope (%)	N/A

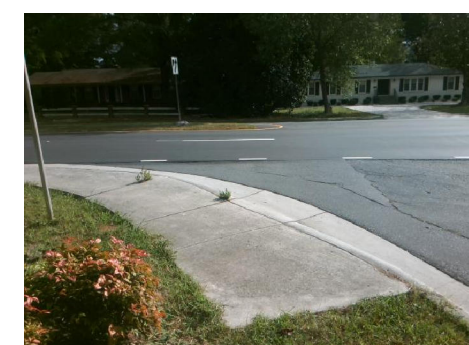
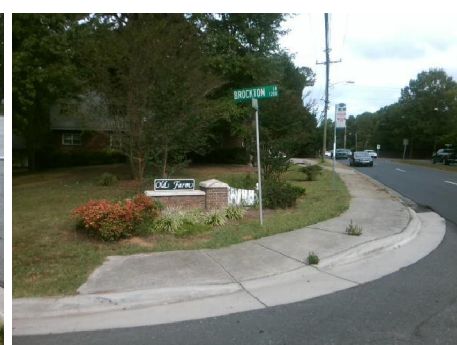
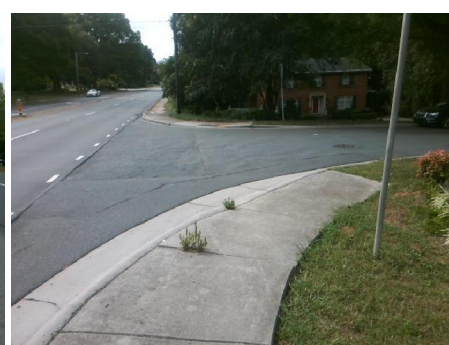
N/A	Gutter Lip Ht (in)	N/A	N/A	Gutter X Slope (%)	N/A
		N/A	Painted X Walk1?	No	N/A	Painted X Walk2?	No
<p>Total Cost: \$ 3200.00</p>			X Walk 1 Direction	To SE		X Walk 2 Direction	To NE
		N/A	X Walk 1 Width (in)	N/A	N/A	X Walk 2 Width (in)	N/A
			X Walk 1 Slope (%)	1.4		X Walk 2 Slope (%)	1.8
			X Walk 1 X Slope (%)	3.1		X Walk 2 X Slope (%)	2.7
		N/A	Ramp inside XWalk1?	N/A	N/A	Ramp inside XWalk2?	N/A
			Road Slope (%)	4.8	N/A	Clear Space?	N/A
			Road X Slope (%)	2.4	N/A	Clear Space to XWalk (in)	N/A
		N/A	Any Obstructions?	N/A	N/A	Storm Grate/Utility Hazard?	N/A
			Obstruction Type			Storm Grate/Utility Type	
				N/A			N/A
					Yes	Surface Condition? (G/P)	Good
