Access Compliance Report

Public Rights-of-Way

(Curb Ramps)

Intersection ID: 13740	Main Street: CENTRAL_AV	Cross Street: LONGFELLOW_ST	Location: NE
ADA ID: 22D1B86EA5AF	Ramp Type: BlendTrans2	Initial Pass/Fail: Fail	Overall Compliance: No
		Severity Score: 10

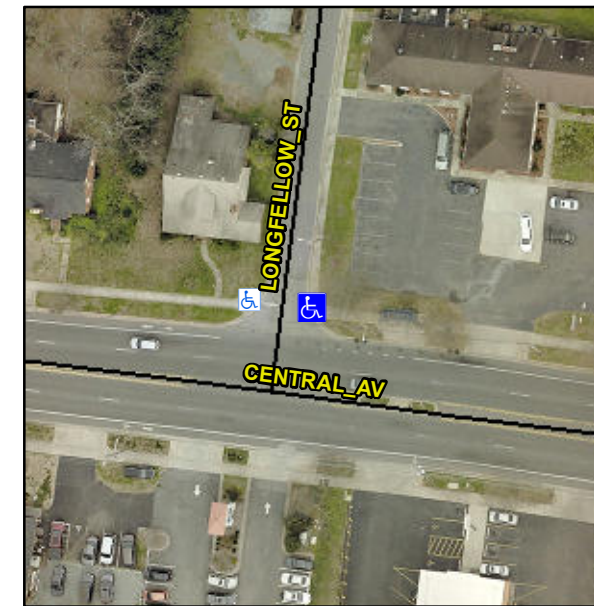
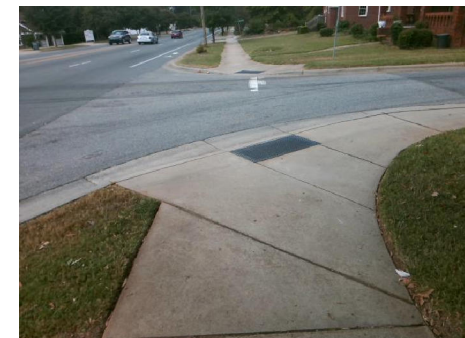
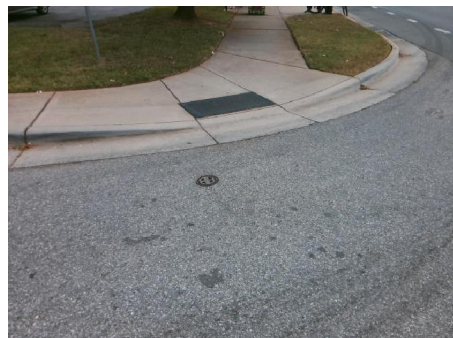
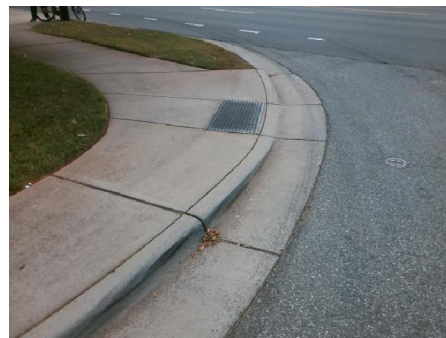
Not Found, R304.5.1, R304.5.3

Compliance	Description	Data	Compliance	Description	Data
N/A	Ramp Length (in)	76.0	Yes	BlendTrans Slope (%)	2.7
No	Ramp Width (in)	39.0	No	BlendTrans XSlope (%)	2.5
N/A	Flare Type LT	N/A	N/A	Flare Type RT	N/A
N/A	Flare Slope LT (%)	N/A	N/A	Flare Slope RT (%)	N/A
N/A	Flare Traversable LT?	N/A	N/A	Flare Traversable RT?	N/A
N/A	Landing Length (in)	N/A	N/A	DWS Provided?	N/A
N/A	Landing Width (in)	N/A	N/A	DWS Contrast?	N/A
N/A	Landing Slope (%)	N/A	N/A	DWS Length (in)	N/A
N/A	Landing X Slope (%)	N/A	N/A	DWS Full Width?	N/A
N/A	Landing Curb? (Y/N)	N/A	N/A	DWS Offset (in)	N/A
N/A	Shared Landing?	N/A			
N/A	Gutter Ponding?	N/A	N/A	Gutter Slope (%)	N/A
N/A	Gutter Lip Ht (in)	N/A	N/A	Gutter X Slope (%)	N/A
N/A	Painted X Walk1?	No	N/A	Painted X Walk2?	N/A
	X Walk 1 Direction	To W		X Walk 2 Direction	N/A
	X Walk 1 Width (in)	N/A		X Walk 2 Width (in)	N/A
	X Walk 1 Slope (%)	0.2		X Walk 2 Slope (%)	N/A
	X Walk 1 X Slope (%)	3.7		X Walk 2 X Slope (%)	N/A

N/A	Ramp inside XWalk1?	N/A	N/A	Ramp inside XWalk2?	N/A
	Road Slope (%)	3.7		Clear Space?	N/A
	Road X Slope (%)	0.2	N/A	Clear Space to XWalk (in)	N/A
N/A	Any Obstructions?	N/A	N/A	Storm Grate/Utility Hazard?	N/A
	Obstruction Type			Storm Grate/Utility Type	
		N/A			N/A
			Yes	Surface Condition? (G/P)	Good
			No	Curb Slope (%)	12.3

Remove & Replace Curb Ramp With Two New Directional Ramps or Equivalent.
