# Access Compliance Report

## Public Rights-of-Way

### (Curb Ramps)

Intersection ID: 50203	Main Street: WEDDINGTON_RD	Cross Street: COLTSVIEW_LN	Location: SW
ADA ID: 22E05BC8253E	Ramp Type: BlendTrans1	Initial Pass/Fail: Fail	Overall Compliance: No
Severity Score: 8.75			
Codes/Mitigation Info/Possible Solution		Field Measurements/Component Compliance

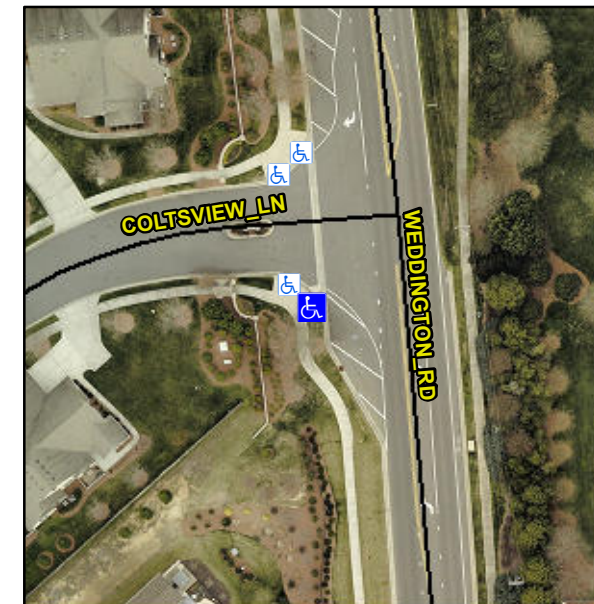
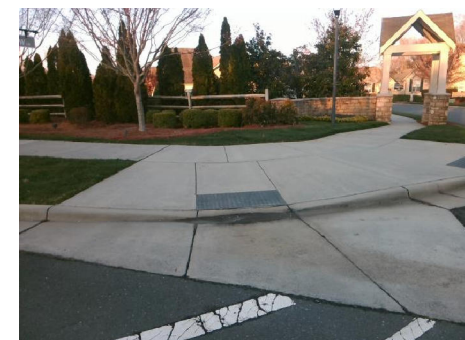
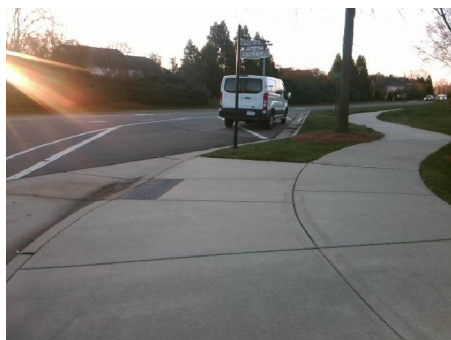
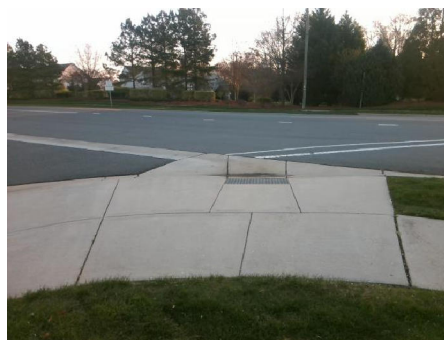
**Not Found, R304.5.1**

Compliance	Description	Data	Compliance	Description	Data
N/A	Ramp Length (in)	97.0	Yes	BlendTrans Slope (%)	4.6
No	Ramp Width (in)	47.5	Yes	BlendTrans XSlope (%)	0.0
N/A	Flare Type LT	N/A	N/A	Flare Type RT	N/A
N/A	Flare Slope LT (%)	N/A	N/A	Flare Slope RT (%)	N/A
N/A	Flare Traversable LT?	N/A	N/A	Flare Traversable RT?	N/A
N/A	Landing Length (in)	N/A	N/A	DWS Provided?	N/A
N/A	Landing Width (in)	N/A	N/A	DWS Contrast?	N/A
N/A	Landing Slope (%)	N/A	N/A	DWS Length (in)	N/A
N/A	Landing X Slope (%)	N/A	N/A	DWS Full Width?	N/A
N/A	Landing Curb? (Y/N)	N/A	N/A	DWS Offset (in)	N/A
N/A	Shared Landing?	N/A			
N/A	Gutter Ponding?	N/A	N/A	Gutter Slope (%)	N/A
N/A	Gutter Lip Ht (in)	N/A	N/A	Gutter X Slope (%)	N/A
N/A	Painted X Walk1?	No	N/A	Painted X Walk2?	N/A
	X Walk 1 Direction	To E		X Walk 2 Direction	N/A
	X Walk 1 Width (in)	N/A		X Walk 2 Width (in)	N/A
	X Walk 1 Slope (%)	0.2		X Walk 2 Slope (%)	N/A
	X Walk 1 X Slope (%)	1.8		X Walk 2 X Slope (%)	N/A

N/A	Ramp inside XWalk1?	N/A	N/A	Ramp inside XWalk2?	N/A
	Road Slope (%)	1.8		Clear Space?	N/A
	Road X Slope (%)	0.2	N/A	Clear Space to XWalk (in)	N/A
N/A	Any Obstructions?	N/A	N/A	Storm Grate/Utility Hazard?	N/A
	Obstruction Type			Storm Grate/Utility Type	
		N/A			N/A
			Yes	Surface Condition? (G/P)	Good
			No	Curb Slope (%)	10.3

**Remove & Replace Curb Ramp With Two New Directional Ramps or Equivalent.**
