## **Access Compliance Report Public Rights-of-Way** (Curb Ramps)

Intersection ID: 13708 Main Street: WEST BV Cross Street: WICKFORD PL Location: SW ADA ID: 22E9B65BB602 Ramp Type: BlendTrans2 Initial Pass/Fail: Fail **Overall Compliance: No Severity Score:** 1.25

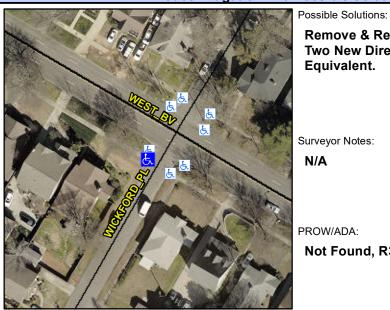
Not Found, R304.5.3

Field Measurements/Component Compliance						
Compl	iance Description	Data	Compli	ance	Description	Data
N/A	Ramp Length (in)	58.0	Yes	Blend	ITrans Slope (%)	4.0
Yes	Ramp Width (in)	50.0	No	Blend	lTrans XSlope (%)	3.0
N/A	Flare Type LT	N/A	N/A	Flare	Type RT	N/A
N/A	Flare Slope LT (%)	N/A	N/A	Flare	Slope RT (%)	N/A
N/A	Flare Traversable LT?	N/A	N/A	Flare	Traversable RT?	N/A
N/A	Landing Length (in)	N/A	N/A	DWS	Provided?	N/A
N/A	Landing Width (in)	N/A	N/A	DWS	Contrast?	N/A
N/A	Landing Slope (%)	N/A	N/A	DWS	Length (in)	N/A
N/A	Landing X Slope (%)	N/A	N/A	DWS	Full Width?	N/A
N/A	Landing Curb? (Y/N)	N/A	N/A	DWS	Offset (in)	N/A
N/A	Shared Landing?	N/A				
N/A	Gutter Ponding?	N/A	N/A	Gutte	er Slope (%)	N/A
N/A	Gutter Lip Ht (in)	N/A	N/A	Gutte	er X Slope (%)	N/A
N/A	Painted X Walk1?	No	N/A	Paint	ed X Walk2?	N/A
	X Walk 1 Direction	To SE		X Wa	lk 2 Direction	N/A
	X Walk 1 Width (in)	N/A		X Wa	lk 2 Width (in)	N/A
	X Walk 1 Slope (%)	5.2		X Wa	lk 2 Slope (%)	N/A

X Walk 1 X Slope (%)	2.3		X Wa	lk 2 X Slope (%)	N/A
N/A	Ramp inside XWalk1?	N/A	N/A	Ram	o inside XWalk2?	N/A
	Road Slope (%)	2.3		Clear	Space?	N/A
	Road X Slope (%)	5.2	N/A	Clear	Space to XWalk (in)	N/A
N/A	Any Obstructions?	N/A	N/A	Storn	n Grate/Utility Hazard?	N/A
	Obstruction Type			Storn	n Grate/Utility Type	
		N/A				N/A
			Yes	Surfa	ce Condition? (G/P)	Good
			No	Curb	Slope (%)	7.8

Street 1 Name **WICKFORD PL** Stop Condition-Street 1 StopSign Street 2 Name N/A Stop Condition-Street 2 N/A Remove & Replace Curb Ramp With Two New Directional Ramps or Equivalent.

3200.00
