Access Compliance Report

Public Rights-of-Way

(Curb Ramps)

Intersection ID: 8938	Main Street: NORRIS_AV	Cross Street: NEWLAND_RD	Location: SW
ADA ID: 22EA97DB41AF	Ramp Type: Perp	Initial Pass/Fail: Fail	Overall Compliance: No
Severity Score: 21.25			
Codes/Mitigation Info/Possible Solution		Field Measurements/Component Compliance

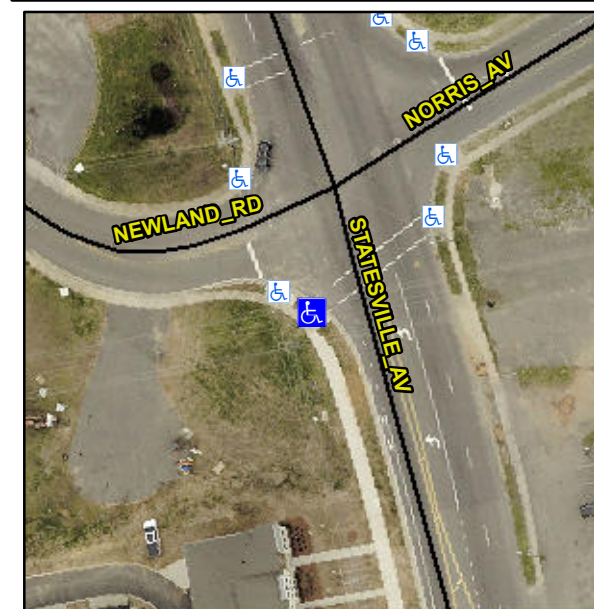
Not Found, R304.5.1, R304.2.2

Compliance	Description	Data	Compliance	Description	Data
N/A	Ramp Length (in)	59.0	No	Ramp Slope (%)	8.5
No	Ramp Width (in)	41.5	Yes	Ramp XSlope (%)	1.6
N/A	Flare Type LT	N/A	N/A	Flare Type RT	N/A
N/A	Flare Slope LT (%)	N/A	N/A	Flare Slope RT (%)	N/A
N/A	Flare Traversable LT?	N/A	N/A	Flare Traversable RT?	N/A
N/A	Landing Length (in)	N/A	N/A	DWS Provided?	N/A
N/A	Landing Width (in)	N/A	N/A	DWS Contrast?	N/A
N/A	Landing Slope (%)	N/A	N/A	DWS Length (in)	N/A
N/A	Landing X Slope (%)	N/A	N/A	DWS Full Width?	N/A
N/A	Landing Curb? (Y/N)	N/A	N/A	DWS Offset (in)	N/A
N/A	Shared Landing?	N/A			
N/A	Gutter Ponding?	N/A	N/A	Gutter Slope (%)	N/A
N/A	Gutter Lip Ht (in)	N/A	N/A	Gutter X Slope (%)	N/A
N/A	Painted X Walk1?	Yes	N/A	Painted X Walk2?	N/A
	X Walk 1 Direction	To NE		X Walk 2 Direction	N/A
N/A	X Walk 1 Width (in)	111.0	N/A	X Walk 2 Width (in)	N/A
	X Walk 1 Slope (%)	3.2		X Walk 2 Slope (%)	N/A
	X Walk 1 X Slope (%)	2.2		X Walk 2 X Slope (%)	N/A

N/A	Ramp inside XWalk1?	Yes	N/A	Ramp inside XWalk2?	N/A
	Road Slope (%)	N/A	N/A	Clear Space?	N/A
	Road X Slope (%)	N/A	N/A	Clear Space to XWalk (in)	N/A
N/A	Any Obstructions?	N/A	N/A	Storm Grate/Utility Hazard?	N/A
	Obstruction Type			Storm Grate/Utility Type	
		N/A			N/A
			Yes	Surface Condition? (G/P)	Good

Possible Solutions:

Remove & Replace Entire Ramp.
